Management Survey

St. Johns Rc School
Avocet Way
Banbury
Oxfordshire
OX16 9YA

Amity

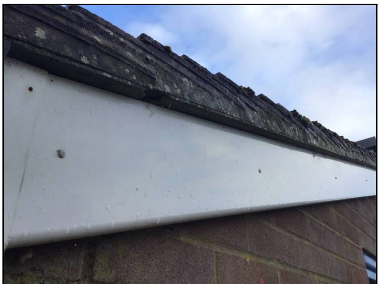
Survey Date:	Lead Surveyor	Survey Type	Floor	Analysis
	21 Dec 2022	Matthew Monro	Management Survey	External	Chrysotile (1)
	Building	Room	Item	Quantity	
	St Johns School	External areas E01	Undercloaking Garden store	6lm	
	Sample No (S,SP,P,As)	Product Type	Surface Treatment	Condition	Accessibility
	AB005164 (S)	Asbestos Cement (1)	Surface Sealed (1)	Low Damage (1)	Usually inaccessible or unlikely to be disturbed
	Material Risk Score				
Recommended action		D - No Attention Required, Label			
Surveyor comments		Undercloaking to pitched roof of garden store

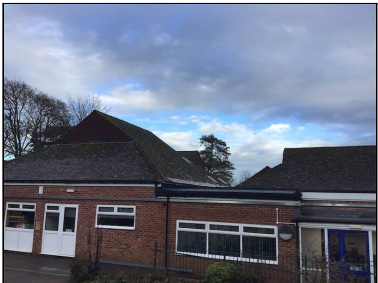
Survey Date:	Lead Surveyor	Survey Type	Floor	Analysis
	21 Dec 2022	Matthew Monro	Management Survey	External	N/A
	Building	Room	Item	Quantity	
	St Johns School	External areas E01	Undercloaking Pitched roofs	N/A	
	Sample No (S,SP,P,As)	Product Type	Surface Treatment	Condition	Accessibility
	Visual (P)	N/A	N/A	N/A	N/A
	Material Risk Score				
Recommended action		Inspection Required			
Surveyor comments		Presumed asbestos undercloaking to gables of 6 pitched roofs. Unable to access due to height.

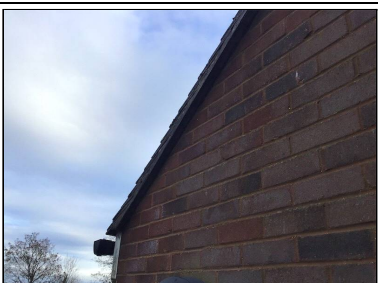
Survey Date:	Lead Surveyor	Survey Type	Floor	Analysis
	21 Dec 2022	Matthew Monro	Management Survey	External	Chrysotile (1)
	Building	Room	Item	Quantity	
	St Johns School	External areas E01	Undercloaking Cloaks	4lm	
	Sample No (S,SP,P,As)	Product Type	Surface Treatment	Condition	Accessibility
	As AB005164 (SP)	Asbestos Cement (1)	Surface Sealed (1)	Low Damage (1)	Usually inaccessible or unlikely to be disturbed
	Material Risk Score				
	4				
Recommended action	D - No Attention Required, Label				
Surveyor comments	Undercloaking to pitched roof of cloak room. See drawing for location.

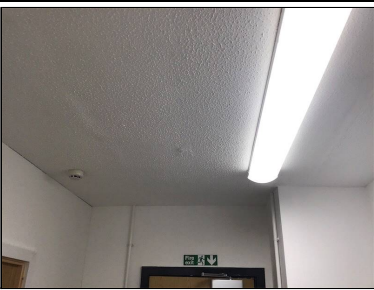
Survey Date:	Lead Surveyor	Survey Type	Floor	Analysis
	21 Dec 2022	Matthew Monro	Management Survey	Ground Floor	Chrysotile (1)
	Building	Room	Item	Quantity	
	St Johns School	Printing G02	Textured coating Ceiling	6m²	
	Sample No (S,SP,P,As)	Product Type	Surface Treatment	Condition	Accessibility
	AB005150 (S)	Textured Coating (1)	Surface Sealed (1)	Good Condition (0)	Usually inaccessible or unlikely to be disturbed
		Material Risk Score			
	3				
Recommended action	D - No Attention Required, Label				
Surveyor comments	Textured coating to ceiling

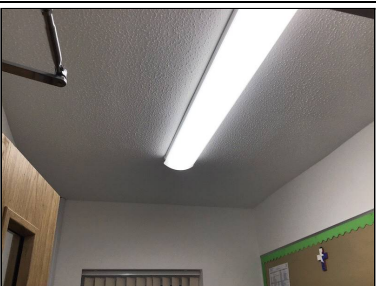
Survey Date:	Lead Surveyor	Survey Type	Floor	Analysis
	21 Dec 2022	Matthew Monro	Management Survey	Ground Floor	Chrysotile (1)
	Building	Room	Item	Quantity	
	St Johns School	Office G03	Textured coating Ceiling	6m²	
	Sample No (S,SP,P,As)	Product Type	Surface Treatment	Condition	Accessibility
	As AB005150 (SP)	Textured Coating (1)	Surface Sealed (1)	Good Condition (0)	Usually inaccessible or unlikely to be disturbed
	Material Risk Score				
3					
Recommended action	D - No Attention Required, Label				
Surveyor comments	Textured coating to ceiling

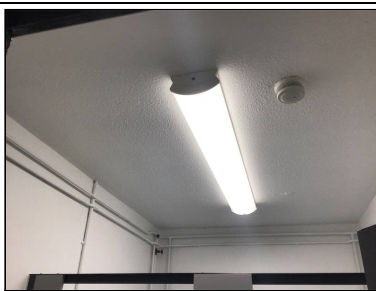
Survey Date:	Lead Surveyor	Survey Type	Floor	Analysis
	21 Dec 2022	Matthew Monro	Management Survey	Ground Floor	Chrysotile (1)
	Building	Room	Item	Quantity	
	St Johns School	Staff ladies toilet G04	Textured coating Ceiling	5m²	
	Sample No (S,SP,P,As)	Product Type	Surface Treatment	Condition	Accessibility
	AB005151 (S)	Textured Coating (1)	Surface Sealed (1)	Good Condition (0)	Usually inaccessible or unlikely to be disturbed
		Material Risk Score			
	3				
Recommended action	D - No Attention Required, Label				
Surveyor comments	Textured coating to ceiling

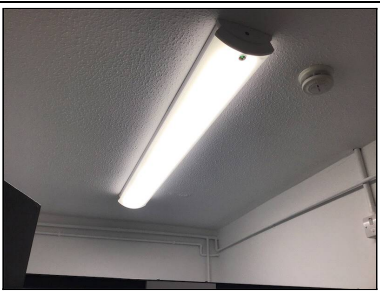
Survey Date:	Lead Surveyor	Survey Type	Floor	Analysis
	21 Dec 2022	Matthew Monro	Management Survey	Ground Floor	Chrysotile (1)
	Building	Room	Item	Quantity	
	St Johns School	Staff gents toilet G05	Textured coating Ceiling	5m²	
	Sample No (S,SP,P,As)	Product Type	Surface Treatment	Condition	Accessibility
	As AB005151 (SP)	Textured Coating (1)	Surface Sealed (1)	Good Condition (0)	Usually inaccessible or unlikely to be disturbed
	Material Risk Score				
3					
Recommended action	D - No Attention Required, Label				
Surveyor comments	Textured coating to ceiling

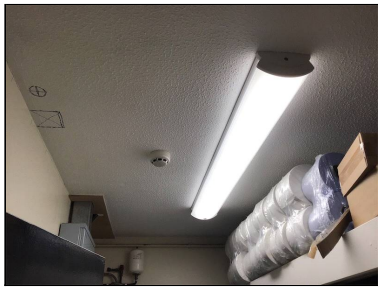
Survey Date:	Lead Surveyor	Survey Type	Floor	Analysis
	21 Dec 2022	Matthew Monro	Management Survey	Ground Floor	Chrysotile (1)
	Building	Room	Item	Quantity	
	St Johns School	Store G06	Textured coating Ceiling	6m²	
	Sample No (S,SP,P,As)	Product Type	Surface Treatment	Condition	Accessibility
	As AB005151 (SP)	Textured Coating (1)	Surface Sealed (1)	Good Condition (0)	Usually inaccessible or unlikely to be disturbed
	Material Risk Score				
3					
Recommended action	D - No Attention Required, Label				
Surveyor comments	Textured coating to ceiling

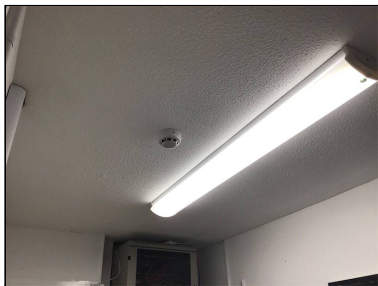
Survey Date:	Lead Surveyor	Survey Type	Floor	Analysis
	21 Dec 2022	Matthew Monro	Management Survey	Ground Floor	Chrysotile (1)
	Building	Room	Item	Quantity	
	St Johns School	IT room G07	Textured coating Ceiling	6m²	
	Sample No (S,SP,P,As)	Product Type	Surface Treatment	Condition	Accessibility
	As AB005151 (SP)	Textured Coating (1)	Surface Sealed (1)	Good Condition (0)	Usually inaccessible or unlikely to be disturbed
	Material Risk Score				
3					
Recommended action	D - No Attention Required, Label				
Surveyor comments	Textured coating to ceiling

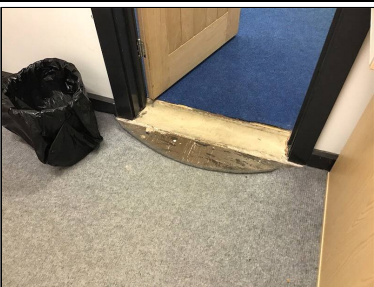
Survey Date:	Lead Surveyor	Survey Type	Floor	Analysis
	21 Dec 2022	Matthew Monro	Management Survey	Ground Floor	Chrysotile (1)
	Building	Room	Item	Quantity	
	St Johns School	IT room G07	Brown tiles and adhesive Floor	6m²	
	Sample No (S,SP,P,As)	Product Type	Surface Treatment	Condition	Accessibility
	AB005152 (S)	Reinforced Composite (1)	Completely Sealed (0)	Low Damage (1)	Easily disturbed
	Material Risk Score				
3					
Recommended action	D - No Attention Required, Label				
Surveyor comments	Brown tiles and adhesive under carpet

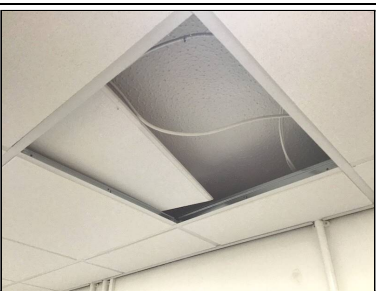
Survey Date:	Lead Surveyor	Survey Type	Floor	Analysis
	21 Dec 2022	Matthew Monro	Management Survey	Ground Floor	Chrysotile (1)
	Building	Room	Item	Quantity	
	St Johns School	Office G08	Textured coating Ceiling	12	
	Sample No (S,SP,P,As)	Product Type	Surface Treatment	Condition	Accessibility
	As AB005151 (SP)	Textured Coating (1)	Surface Sealed (1)	Good Condition (0)	Usually inaccessible or unlikely to be disturbed
	Material Risk Score				
	3				
Recommended action	D - No Attention Required, Label				
Surveyor comments	Textured coating to ceiling

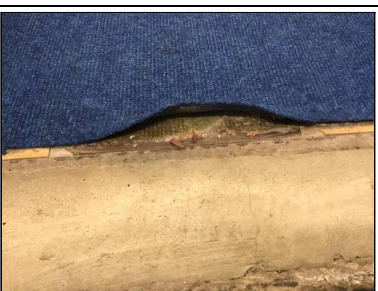
Survey Date:	Lead Surveyor	Survey Type	Floor	Analysis
	21 Dec 2022	Matthew Monro	Management Survey	Ground Floor	Chrysotile (1)
	Building	Room	Item	Quantity	
	St Johns School	Office G08	Brown tiles and adhesive Floor	6m²	
	Sample No (S,SP,P,As)	Product Type	Surface Treatment	Condition	Accessibility
	AB005153 (S)	Reinforced Composite (1)	Completely Sealed (0)	Low Damage (1)	Usually inaccessible or unlikely to be disturbed
	Material Risk Score				
	3				
Recommended action	D - No Attention Required, Label				
Surveyor comments	Brown tiles and adhesive under carpet

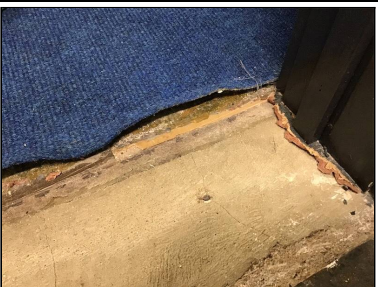
Survey Date:	Lead Surveyor	Survey Type	Floor	Analysis
	21 Dec 2022	Matthew Monro	Management Survey	Ground Floor	Chrysotile (1)
	Building	Room	Item	Quantity	
	St Johns School	Office G08	Cream tiles and adhesive Floor	6m²	
	Sample No (S,SP,P,As)	Product Type	Surface Treatment	Condition	Accessibility
	AB005154 (S)	Reinforced Composite (1)	Completely Sealed (0)	Good Condition (0)	Usually inaccessible or unlikely to be disturbed
	Material Risk Score				
	2				
Recommended action	D - No Attention Required, Label				
Surveyor comments	Cream tiles and adhesive under carpet

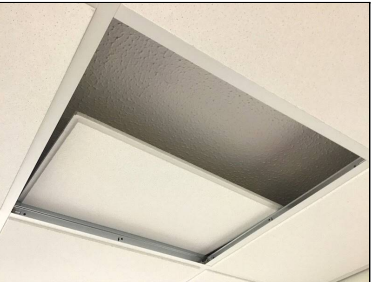
Survey Date:	Lead Surveyor	Survey Type	Floor	Analysis
	21 Dec 2022	Matthew Monro	Management Survey	Ground Floor	Chrysotile (1)
	Building	Room	Item	Quantity	
	St Johns School	Head teachers office G09	Textured coating Ceiling	17m ²	
	Sample No (S,SP,P,As)	Product Type	Surface Treatment	Condition	Accessibility
	As AB005151 (SP)	Textured Coating (1)	Surface Sealed (1)	Good Condition (0)	Usually inaccessible or unlikely to be disturbed
	Material Risk Score				
Recommended action		D - No Attention Required, Label			
Surveyor comments		Textured coating to ceiling

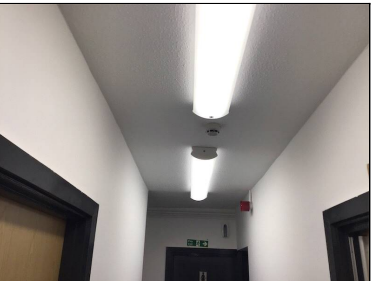
Survey Date:	Lead Surveyor	Survey Type	Floor	Analysis
	21 Dec 2022	Matthew Monro	Management Survey	Ground Floor	Chrysotile (1)
	Building	Room	Item	Quantity	
	St Johns School	Staff circulation G10	Textured coating Ceiling	10m ²	
	Sample No (S,SP,P,As)	Product Type	Surface Treatment	Condition	Accessibility
	As AB005151 (SP)	Textured Coating (1)	Surface Sealed (1)	Good Condition (0)	Usually inaccessible or unlikely to be disturbed
	Material Risk Score				
Recommended action		D - No Attention Required, Label			
Surveyor comments		Textured coating to ceiling

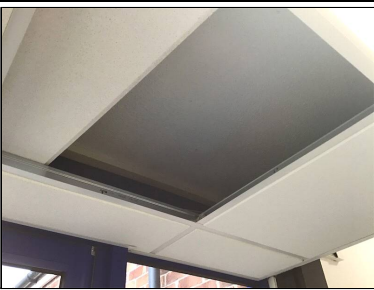
Survey Date:	Lead Surveyor	Survey Type	Floor	Analysis
	21 Dec 2022	Matthew Monro	Management Survey	Ground Floor	Chrysotile (1)
	Building	Room	Item	Quantity	
	St Johns School	Entrance G11	Textured coating Ceiling	20m²	
	Sample No (S,SP,P,As)	Product Type	Surface Treatment	Condition	Accessibility
	AB005155 (S)	Textured Coating (1)	Surface Sealed (1)	Good Condition (0)	Usually inaccessible or unlikely to be disturbed
	Material Risk Score				
3					
Recommended action	D - No Attention Required, Label				
Surveyor comments	Textured coating to ceiling

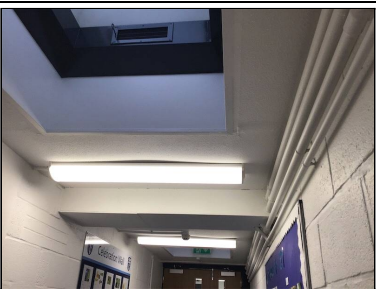
Survey Date:	Lead Surveyor	Survey Type	Floor	Analysis
	21 Dec 2022	Matthew Monro	Management Survey	Ground Floor	Chrysotile (1)
	Building	Room	Item	Quantity	
	St Johns School	Circulation G12	Textured coating Ceiling	17m²	
	Sample No (S,SP,P,As)	Product Type	Surface Treatment	Condition	Accessibility
	As AB005155 (SP)	Textured Coating (1)	Surface Sealed (1)	Good Condition (0)	Occasionally likely to be disturbed
	Material Risk Score				
3					
Recommended action	D - No Attention Required, Label				
Surveyor comments	Textured coating to ceiling

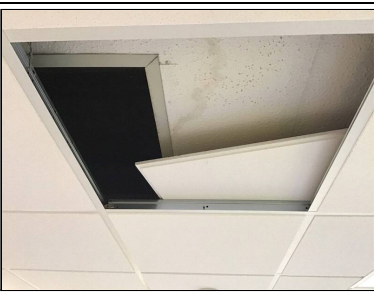
Survey Date:	Lead Surveyor	Survey Type	Floor	Analysis
	21 Dec 2022	Matthew Monro	Management Survey	Ground Floor	Chrysotile (1)
	Building	Room	Item	Quantity	
	St Johns School	Reception classroom G13	Textured coating Ceiling	120m²	
	Sample No (S,SP,P,As)	Product Type	Surface Treatment	Condition	Accessibility
	AB005156 (S)	Textured Coating (1)	Surface Sealed (1)	Good Condition (0)	Occasionally likely to be disturbed
	Material Risk Score				
3					
Recommended action	D - No Attention Required, Label				
Surveyor comments	Textured coating to ceiling

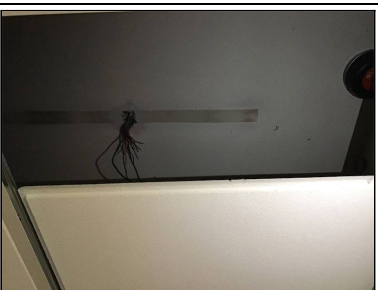
Survey Date:	Lead Surveyor	Survey Type	Floor	Analysis
	21 Dec 2022	Matthew Monro	Management Survey	Ground Floor	Chrysotile (1)
	Building	Room	Item	Quantity	
	St Johns School	Kitchen G14	Textured coating Ceiling	10m²	
	Sample No (S,SP,P,As)	Product Type	Surface Treatment	Condition	Accessibility
	As AB005156 (SP)	Textured Coating (1)	Surface Sealed (1)	Good Condition (0)	Occasionally likely to be disturbed
	Material Risk Score				
3					
Recommended action	D - No Attention Required, Label				
Surveyor comments	Textured coating to ceiling

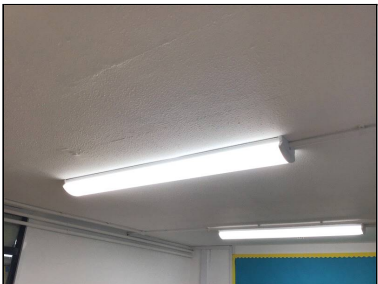
Survey Date:	Lead Surveyor	Survey Type	Floor	Analysis
	21 Dec 2022	Matthew Monro	Management Survey	Ground Floor	Chrysotile (1)
	Building	Room	Item	Quantity	
	St Johns School	Reception classroom 2 G15	Textured coating Ceiling	40m ²	
	Sample No (S,SP,P,As)	Product Type	Surface Treatment	Condition	Accessibility
	As AB005156 (SP)	Textured Coating (1)	Surface Sealed (1)	Good Condition (0)	Occasionally likely to be disturbed
	Material Risk Score				
Recommended action		D - No Attention Required, Label			
Surveyor comments		Textured coating to ceiling

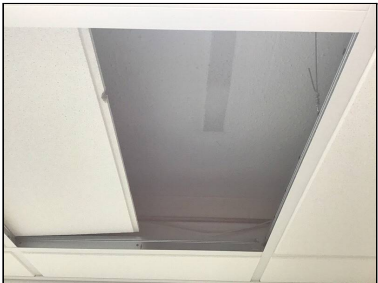
Survey Date:	Lead Surveyor	Survey Type	Floor	Analysis
	21 Dec 2022	Matthew Monro	Management Survey	Ground Floor	Chrysotile (1)
	Building	Room	Item	Quantity	
	St Johns School	Disabled toilet G16	Textured coating Ceiling	8m ²	
	Sample No (S,SP,P,As)	Product Type	Surface Treatment	Condition	Accessibility
	As AB005156 (SP)	Textured Coating (1)	Surface Sealed (1)	Good Condition (0)	Usually inaccessible or unlikely to be disturbed
	Material Risk Score				
Recommended action		D - No Attention Required, Label			
Surveyor comments		Textured coating to ceiling

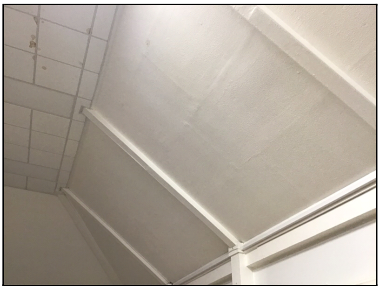
Survey Date:	Lead Surveyor	Survey Type	Floor	Analysis
	21 Dec 2022	Matthew Monro	Management Survey	Ground Floor	Chrysotile (1)
	Building	Room	Item	Quantity	
	St Johns School	School hall G18	Textured coating Pitched ceiling	250m ²	
	Sample No (S,SP,P,As)	Product Type	Surface Treatment	Condition	Accessibility
	AB005157 (S)	Textured Coating (1)	Surface Sealed (1)	Good Condition (0)	Usually inaccessible or unlikely to be disturbed
	Material Risk Score				
Recommended action		D - No Attention Required, Label			
Surveyor comments		Textured coating to pitched ceiling in hall

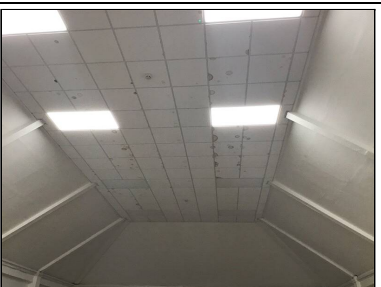
Survey Date:	Lead Surveyor	Survey Type	Floor	Analysis
	21 Dec 2022	Matthew Monro	Management Survey	Ground Floor	N/A
	Building	Room	Item	Quantity	
	St Johns School	School hall G18	Suspended ceiling	N/A	
	Sample No (S,SP,P,As)	Product Type	Surface Treatment	Condition	Accessibility
	Visual (P)	N/A	N/A	N/A	N/A
	Material Risk Score				
	N/A				
Recommended action	Inspection Required				
Surveyor comments	No access above ceiling due to height

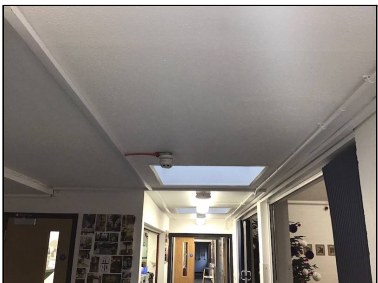
Survey Date:	Lead Surveyor	Survey Type	Floor	Analysis
	21 Dec 2022	Matthew Monro	Management Survey	Ground Floor	Chrysotile (1)
	Building	Room	Item	Quantity	
	St Johns School	Servery circulation G21	Textured coating Pitched ceiling	10m ²	
	Sample No (S,SP,P,As)	Product Type	Surface Treatment	Condition	Accessibility
	As AB005157 (SP)	Textured Coating (1)	Surface Sealed (1)	Good Condition (0)	Occasionally likely to be disturbed
	Material Risk Score				
Recommended action		D - No Attention Required, Label			
Surveyor comments		Textured coating to pitched ceiling in hall

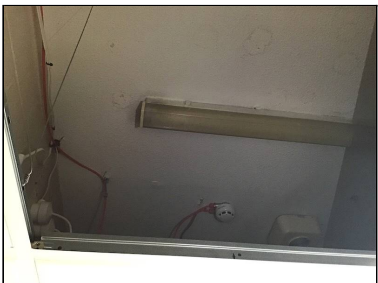
Survey Date:	Lead Surveyor	Survey Type	Floor	Analysis
	21 Dec 2022	Matthew Monro	Management Survey	Ground Floor	Chrysotile (1)
	Building	Room	Item	Quantity	
	St Johns School	Girls toilet G23	Textured coating Ceiling	6m ²	
	Sample No (S,SP,P,As)	Product Type	Surface Treatment	Condition	Accessibility
	AB005158 (S)	Textured Coating + Well Bound Material (1)	Surface Sealed (1)	Good Condition (0)	Usually inaccessible or unlikely to be disturbed
	Material Risk Score				
Recommended action		D - No Attention Required, Label			
Surveyor comments		Textured coating to ceiling

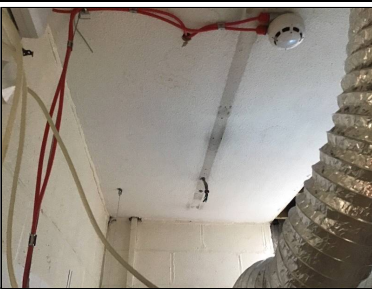
Survey Date:	Lead Surveyor	Survey Type	Floor	Analysis
	21 Dec 2022	Matthew Monro	Management Survey	Ground Floor	Chrysotile (1)
	Building	Room	Item	Quantity	
	St Johns School	Boys toilet G24	Textured coating Ceiling	6m²	
	Sample No (S,SP,P,As)	Product Type	Surface Treatment	Condition	Accessibility
	As AB005158 (SP)	Textured Coating + Well Bound Material (1)	Surface Sealed (1)	Good Condition (0)	Usually inaccessible or unlikely to be disturbed
	Material Risk Score				
	3				
Recommended action	D - No Attention Required, Label				
Surveyor comments	Textured coating to ceiling

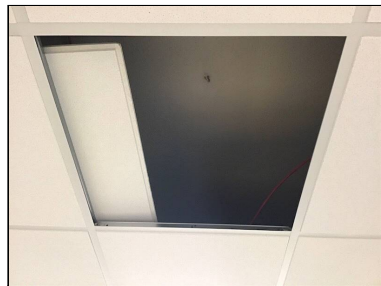
Survey Date:	Lead Surveyor	Survey Type	Floor	Analysis
	21 Dec 2022	Matthew Monro	Management Survey	Ground Floor	Chrysotile (1)
	Building	Room	Item	Quantity	
	St Johns School	Year 2 classroom G25	Textured coating Ceiling	62m²	
	Sample No (S,SP,P,As)	Product Type	Surface Treatment	Condition	Accessibility
	As AB005158 (SP)	Textured Coating + Well Bound Material (1)	Surface Sealed (1)	Good Condition (0)	Usually inaccessible or unlikely to be disturbed
	Material Risk Score				
	3				
Recommended action	D - No Attention Required, Label				
Surveyor comments	Textured coating to ceiling

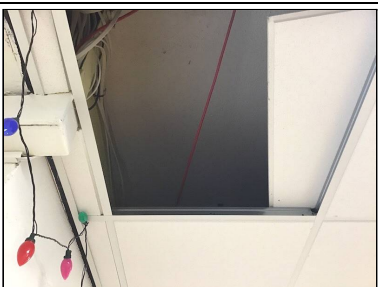
Survey Date:	Lead Surveyor	Survey Type	Floor	Analysis
	21 Dec 2022	Matthew Monro	Management Survey	Ground Floor	Chrysotile (1)
	Building	Room	Item	Quantity	
	St Johns School	Year 3 and 4 classroom G28	Textured coating Ceiling	55m²	
	Sample No (S,SP,P,As)	Product Type	Surface Treatment	Condition	Accessibility
	As AB005158 (SP)	Textured Coating + Well Bound Material (1)	Surface Sealed (1)	Good Condition (0)	Usually inaccessible or unlikely to be disturbed
	Material Risk Score				
3					
Recommended action	D - No Attention Required, Label				
Surveyor comments	Textured coating to ceiling

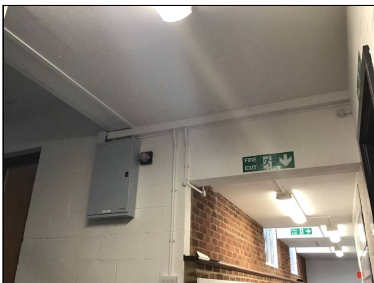
Survey Date:	Lead Surveyor	Survey Type	Floor	Analysis
	21 Dec 2022	Matthew Monro	Management Survey	Ground Floor	Chrysotile (1)
	Building	Room	Item	Quantity	
	St Johns School	Cloaks and circulation G29	Textured coating Ceiling	30m²	
	Sample No (S,SP,P,As)	Product Type	Surface Treatment	Condition	Accessibility
	As AB005158 (SP)	Textured Coating + Well Bound Material (1)	Surface Sealed (1)	Good Condition (0)	Usually inaccessible or unlikely to be disturbed
	Material Risk Score				
3					
Recommended action	D - No Attention Required, Label				
Surveyor comments	Textured coating to ceiling

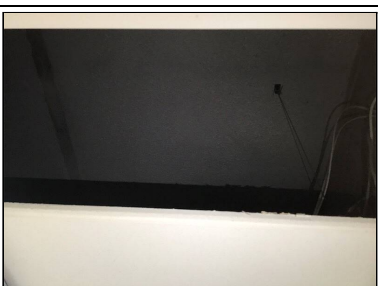
Survey Date:	Lead Surveyor	Survey Type	Floor	Analysis
	21 Dec 2022	Matthew Monro	Management Survey	Ground Floor	Chrysotile (1)
	Building	Room	Item	Quantity	
	St Johns School	Girls toilet G30	Textured coating Ceiling	8m²	
	Sample No (S,SP,P,As)	Product Type	Surface Treatment	Condition	Accessibility
	As AB005158 (SP)	Textured Coating + Well Bound Material (1)	Surface Sealed (1)	Good Condition (0)	Usually inaccessible or unlikely to be disturbed
	Material Risk Score				
	3				
Recommended action	D - No Attention Required, Label				
Surveyor comments	Textured coating to ceiling

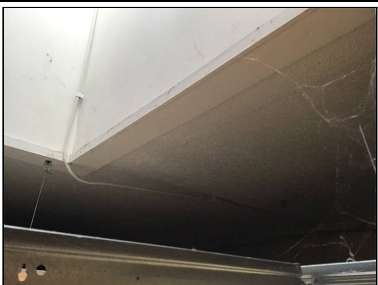
Survey Date:	Lead Surveyor	Survey Type	Floor	Analysis
	21 Dec 2022	Matthew Monro	Management Survey	Ground Floor	Chrysotile (1)
	Building	Room	Item	Quantity	
	St Johns School	Year 12 classroom G31	Textured coating Ceiling	75m²	
	Sample No (S,SP,P,As)	Product Type	Surface Treatment	Condition	Accessibility
	As AB005158 (SP)	Textured Coating + Well Bound Material (1)	Surface Sealed (1)	Good Condition (0)	Usually inaccessible or unlikely to be disturbed
	Material Risk Score				
	3				
Recommended action	D - No Attention Required, Label				
Surveyor comments	Textured coating to ceiling

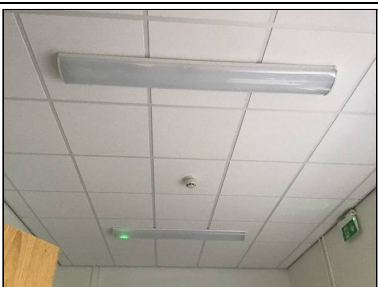
Survey Date:	Lead Surveyor	Survey Type	Floor	Analysis
	21 Dec 2022	Matthew Monro	Management Survey	Ground Floor	Chrysotile (1)
	Building	Room	Item	Quantity	
	St Johns School	SENDco room G32	Textured coating Ceiling	18m²	
	Sample No (S,SP,P,As)	Product Type	Surface Treatment	Condition	Accessibility
	As AB005158 (SP)	Textured Coating + Well Bound Material (1)	Surface Sealed (1)	Good Condition (0)	Usually inaccessible or unlikely to be disturbed
	Material Risk Score				
	3				
Recommended action	D - No Attention Required, Label				
Surveyor comments	Textured coating to ceiling

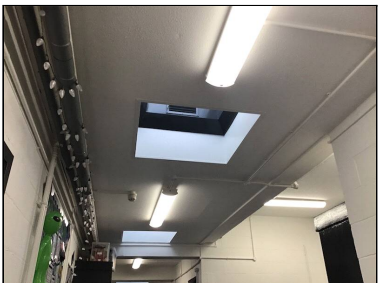
Survey Date:	Lead Surveyor	Survey Type	Floor	Analysis
	21 Dec 2022	Matthew Monro	Management Survey	Ground Floor	Chrysotile (1)
	Building	Room	Item	Quantity	
	St Johns School	Circulation G33	Textured coating Ceiling	30m²	
	Sample No (S,SP,P,As)	Product Type	Surface Treatment	Condition	Accessibility
	As AB005158 (SP)	Textured Coating + Well Bound Material (1)	Surface Sealed (1)	Good Condition (0)	Usually inaccessible or unlikely to be disturbed
	Material Risk Score				
	3				
Recommended action	D - No Attention Required, Label				
Surveyor comments	Textured coating to ceiling

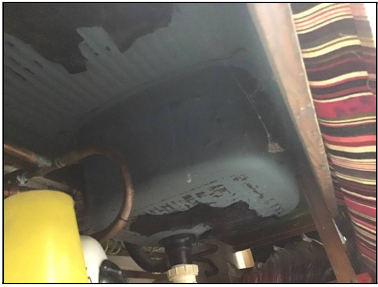
Survey Date:	Lead Surveyor	Survey Type	Floor	Analysis
	21 Dec 2022	Matthew Monro	Management Survey	Ground Floor	Chrysotile (1)
	Building	Room	Item	Quantity	
	St Johns School	Circulation G33	Acoustic pads Sink	2m ²	
	Sample No (S,SP,P,As)	Product Type	Surface Treatment	Condition	Accessibility
	AB005159 (S)	Reinforced Composite (1)	Completely Sealed (0)	Low Damage (1)	Usually inaccessible or unlikely to be disturbed
	Material Risk Score				
Recommended action		D - No Attention Required, Label			
Surveyor comments		Acoustic pads to underside of sink unit

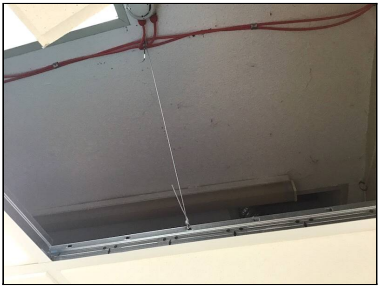
Survey Date:	Lead Surveyor	Survey Type	Floor	Analysis
	21 Dec 2022	Matthew Monro	Management Survey	Ground Floor	Chrysotile (1)
	Building	Room	Item	Quantity	
	St Johns School	Boys toilet G34	Textured coating Ceiling	8m ²	
	Sample No (S,SP,P,As)	Product Type	Surface Treatment	Condition	Accessibility
	As AB005158 (SP)	Textured Coating + Well Bound Material (1)	Surface Sealed (1)	Good Condition (0)	Usually inaccessible or unlikely to be disturbed
	Material Risk Score				
Recommended action		D - No Attention Required, Label			
Surveyor comments		Textured coating to ceiling
