# Asbestos Re-inspection Report

St. Johns Rc School  
Avocet Way  
Banbury  
Oxfordshire  
OX16 9YA

For the Attention of	Laura Houghton
Report number	J007611
Inspector(s)	Matthew Monro
Date of last Survey/Inspection	3 Jun 2024
Last Survey/Inspection Report Number	J006916
Date of Re-inspection	23 May 2025
Next inspection due	23 May 2026
Approved By	Matthew Monro
Approving Signature	 
Report Date	27 May 2025

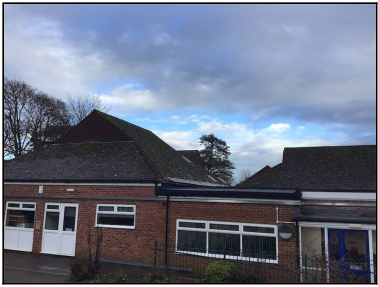
<b>Re-inspection Date:</b>	<b>Lead Surveyor</b>	<b>Survey Type</b>	<b>Floor</b>	<b>Analysis</b>
	23 May 2025	Matthew Monro	Reinspection Survey	External	N/A
	<b>Building</b>	<b>Room</b>	<b>Item</b>	<b>Quantity</b>	
	St Johns School	External areas E01	Undercloaking Pitched roofs	N/A	
	<b>Sample No (S,SP,P,As)</b>	<b>Product Type</b>	<b>Surface Treatment</b>	<b>Condition</b>	<b>Accessibility</b>
	Visual (P)	N/A	N/A	N/A	N/A
	<b>Material Risk Score</b>				
N/A					
<b>Recommended action</b>	Inspection Required				
<b>Surveyor comments</b>	Presumed asbestos undercloaking to gables of 6 pitched roofs. Unable to access due to height.				
<b>Reinspection State</b>	No Change				
<b>Review Comments</b>	No change

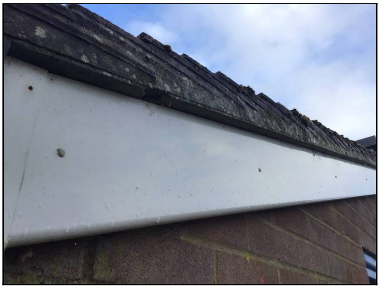
<b>Re-inspection Date:</b>	<b>Lead Surveyor</b>	<b>Survey Type</b>	<b>Floor</b>	<b>Analysis</b>
	23 May 2025	Matthew Monro	Reinspection Survey	External	Chrysotile (1)
	<b>Building</b>	<b>Room</b>	<b>Item</b>	<b>Quantity</b>	
	St Johns School	External areas E01	Undercloaking Garden store	6lm	
	<b>Sample No (S,SP,P,As)</b>	<b>Product Type</b>	<b>Surface Treatment</b>	<b>Condition</b>	<b>Accessibility</b>
	AB005164* (S)	Asbestos Cement (1)	Surface Sealed (1)	Low Damage (1)	Usually inaccessible or unlikely to be disturbed
	<b>Material Risk Score</b>				
4					
<b>Recommended action</b>	D - No Attention Required, Label				
<b>Surveyor comments</b>	Undercloaking to pitched roof of garden store				
<b>Reinspection State</b>	No Change				
<b>Review Comments</b>	No change

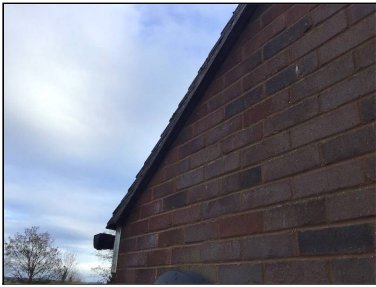
<b>Re-inspection Date:</b>	<b>Lead Surveyor</b>	<b>Survey Type</b>	<b>Floor</b>	<b>Analysis</b>
	23 May 2025	Matthew Monro	Reinspection Survey	External	Chrysotile (1)
	<b>Building</b>	<b>Room</b>	<b>Item</b>	<b>Quantity</b>	
	St Johns School	External areas E01	Undercloaking Cloaks	4lm	
	<b>Sample No (S,SP,P,As)</b>	<b>Product Type</b>	<b>Surface Treatment</b>	<b>Condition</b>	<b>Accessibility</b>
	As AB005164* (SP)	Asbestos Cement (1)	Surface Sealed (1)	Low Damage (1)	Usually inaccessible or unlikely to be disturbed
<b>Material Risk Score</b>					
4					
<b>Recommended action</b>	D - No Attention Required, Label				
<b>Surveyor comments</b>	Undercloaking to pitched roof of cloak room. See drawing for location.				
<b>Reinspection State</b>	No Change				
<b>Review Comments</b>	No change

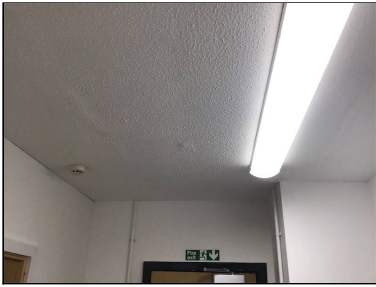
<b>Re-inspection Date:</b>	<b>Lead Surveyor</b>	<b>Survey Type</b>	<b>Floor</b>	<b>Analysis</b>
	23 May 2025	Matthew Monro	Reinspection Survey	Ground Floor	Chrysotile (1)
	<b>Building</b>	<b>Room</b>	<b>Item</b>	<b>Quantity</b>	
	St Johns School	Printing G02	Textured coating Ceiling	6m <sup>2</sup>	
	<b>Sample No (S,SP,P,As)</b>	<b>Product Type</b>	<b>Surface Treatment</b>	<b>Condition</b>	<b>Accessibility</b>
	AB005150* (S)	Textured Coating (1)	Surface Sealed (1)	Good Condition (0)	Usually inaccessible or unlikely to be disturbed
<b>Material Risk Score</b>					
3					
<b>Recommended action</b>	D - No Attention Required, Label				
<b>Surveyor comments</b>	Textured coating to ceiling				
<b>Reinspection State</b>	No Change				
<b>Review Comments</b>	No change

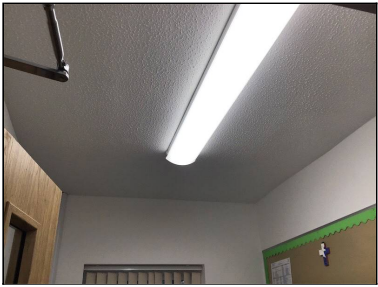
<b>Re-inspection Date:</b>	<b>Lead Surveyor</b>	<b>Survey Type</b>	<b>Floor</b>	<b>Analysis</b>
	23 May 2025	Matthew Monro	Reinspection Survey	Ground Floor	Chrysotile (1)
	<b>Building</b>	<b>Room</b>	<b>Item</b>	<b>Quantity</b>	
	St Johns School	Office G03	Textured coating Ceiling	6m <sup>2</sup>	
	<b>Sample No (S,SP,P,As)</b>	<b>Product Type</b>	<b>Surface Treatment</b>	<b>Condition</b>	<b>Accessibility</b>
	As AB005150* (SP)	Textured Coating (1)	Surface Sealed (1)	Good Condition (0)	Usually inaccessible or unlikely to be disturbed
	<b>Material Risk Score</b>				
3					
<b>Recommended action</b>	D - No Attention Required, Label				
<b>Surveyor comments</b>	Textured coating to ceiling				
<b>Reinspection State</b>	No Change				
<b>Review Comments</b>	No change

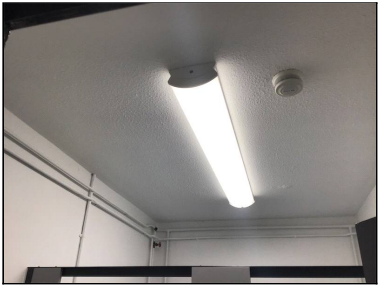
<b>Re-inspection Date:</b>	<b>Lead Surveyor</b>	<b>Survey Type</b>	<b>Floor</b>	<b>Analysis</b>
	23 May 2025	Matthew Monro	Reinspection Survey	Ground Floor	Chrysotile (1)
	<b>Building</b>	<b>Room</b>	<b>Item</b>	<b>Quantity</b>	
	St Johns School	Staff ladies toilet G04	Textured coating Ceiling	5m <sup>2</sup>	
	<b>Sample No (S,SP,P,As)</b>	<b>Product Type</b>	<b>Surface Treatment</b>	<b>Condition</b>	<b>Accessibility</b>
	AB005151* (S)	Textured Coating (1)	Surface Sealed (1)	Good Condition (0)	Usually inaccessible or unlikely to be disturbed
	<b>Material Risk Score</b>				
3					
<b>Recommended action</b>	D - No Attention Required, Label				
<b>Surveyor comments</b>	Textured coating to ceiling				
<b>Reinspection State</b>	No Change				
<b>Review Comments</b>	No change

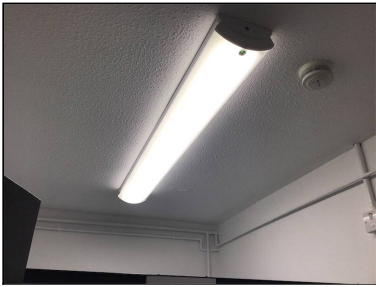
<b>Re-inspection Date:</b>	<b>Lead Surveyor</b>	<b>Survey Type</b>	<b>Floor</b>	<b>Analysis</b>
	23 May 2025	Matthew Monro	Reinspection Survey	Ground Floor	Chrysotile (1)
	<b>Building</b>	<b>Room</b>	<b>Item</b>	<b>Quantity</b>	
	St Johns School	Staff gents toilet G05	Textured coating Ceiling	5m <sup>2</sup>	
	<b>Sample No (S,SP,P,As)</b>	<b>Product Type</b>	<b>Surface Treatment</b>	<b>Condition</b>	<b>Accessibility</b>
	As AB005151* (SP)	Textured Coating (1)	Surface Sealed (1)	Good Condition (0)	Usually inaccessible or unlikely to be disturbed
	<b>Material Risk Score</b>				
3					
<b>Recommended action</b>	D - No Attention Required, Label				
<b>Surveyor comments</b>	Textured coating to ceiling				
<b>Reinspection State</b>	No Change				
<b>Review Comments</b>	No change

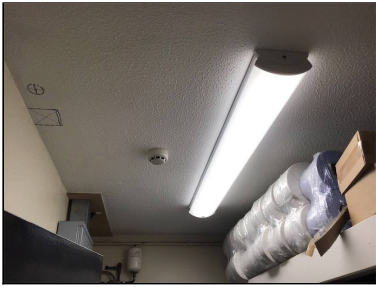
<b>Re-inspection Date:</b>	<b>Lead Surveyor</b>	<b>Survey Type</b>	<b>Floor</b>	<b>Analysis</b>
	23 May 2025	Matthew Monro	Reinspection Survey	Ground Floor	Chrysotile (1)
	<b>Building</b>	<b>Room</b>	<b>Item</b>	<b>Quantity</b>	
	St Johns School	Store G06	Textured coating Ceiling	6m <sup>2</sup>	
	<b>Sample No (S,SP,P,As)</b>	<b>Product Type</b>	<b>Surface Treatment</b>	<b>Condition</b>	<b>Accessibility</b>
	As AB005151* (SP)	Textured Coating (1)	Surface Sealed (1)	Good Condition (0)	Usually inaccessible or unlikely to be disturbed
	<b>Material Risk Score</b>				
3					
<b>Recommended action</b>	D - No Attention Required, Label				
<b>Surveyor comments</b>	Textured coating to ceiling				
<b>Reinspection State</b>	No Change				
<b>Review Comments</b>	No change

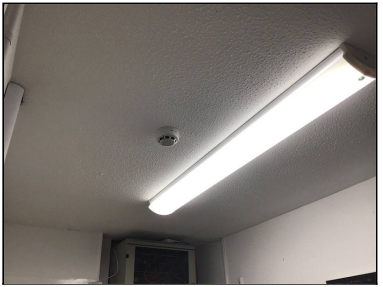
<b>Re-inspection Date:</b>	<b>Lead Surveyor</b>	<b>Survey Type</b>	<b>Floor</b>	<b>Analysis</b>
	23 May 2025	Matthew Monro	Reinspection Survey	Ground Floor	Chrysotile (1)
	<b>Building</b>	<b>Room</b>	<b>Item</b>	<b>Quantity</b>	
	St Johns School	IT room G07	Textured coating Ceiling	6m <sup>2</sup>	
	<b>Sample No (S,SP,P,As)</b>	<b>Product Type</b>	<b>Surface Treatment</b>	<b>Condition</b>	<b>Accessibility</b>
	As AB005151* (SP)	Textured Coating (1)	Surface Sealed (1)	Good Condition (0)	Usually inaccessible or unlikely to be disturbed
<b>Material Risk Score</b>					
3					
<b>Recommended action</b>	D - No Attention Required, Label				
<b>Surveyor comments</b>	Textured coating to ceiling				
<b>Reinspection State</b>	No Change				
<b>Review Comments</b>	No change

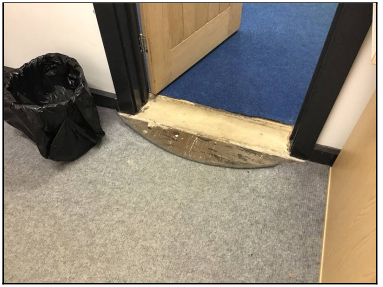
<b>Re-inspection Date:</b>	<b>Lead Surveyor</b>	<b>Survey Type</b>	<b>Floor</b>	<b>Analysis</b>
	23 May 2025	Matthew Monro	Reinspection Survey	Ground Floor	Chrysotile (1)
	<b>Building</b>	<b>Room</b>	<b>Item</b>	<b>Quantity</b>	
	St Johns School	IT room G07	Brown tiles and adhesive Floor	6m <sup>2</sup>	
	<b>Sample No (S,SP,P,As)</b>	<b>Product Type</b>	<b>Surface Treatment</b>	<b>Condition</b>	<b>Accessibility</b>
	AB005152* (S)	Reinforced Composite (1)	Completely Sealed (0)	Low Damage (1)	Easily disturbed
<b>Material Risk Score</b>					
3					
<b>Recommended action</b>	D - No Attention Required, Label				
<b>Surveyor comments</b>	Brown tiles and adhesive under carpet				
<b>Reinspection State</b>	No Change				
<b>Review Comments</b>	No change

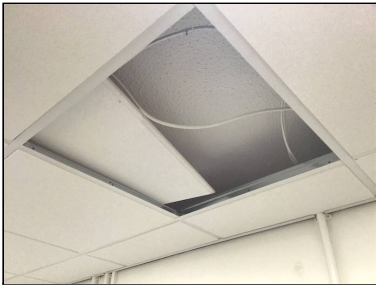
<b>Re-inspection Date:</b>	<b>Lead Surveyor</b>	<b>Survey Type</b>	<b>Floor</b>	<b>Analysis</b>
	23 May 2025	Matthew Monro	Reinspection Survey	Ground Floor	Chrysotile (1)
	<b>Building</b>	<b>Room</b>	<b>Item</b>	<b>Quantity</b>	
	St Johns School	Office G08	Textured coating Ceiling	12	
	<b>Sample No (S,SP,P,As)</b>	<b>Product Type</b>	<b>Surface Treatment</b>	<b>Condition</b>	<b>Accessibility</b>
	As AB005151* (SP)	Textured Coating (1)	Surface Sealed (1)	Good Condition (0)	Usually inaccessible or unlikely to be disturbed
<b>Material Risk Score</b>					
3					
<b>Recommended action</b>	D - No Attention Required, Label				
<b>Surveyor comments</b>	Textured coating to ceiling				
<b>Reinspection State</b>	No Change				
<b>Review Comments</b>	No change

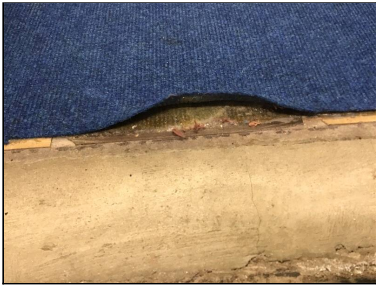
<b>Re-inspection Date:</b>	<b>Lead Surveyor</b>	<b>Survey Type</b>	<b>Floor</b>	<b>Analysis</b>
	23 May 2025	Matthew Monro	Reinspection Survey	Ground Floor	Chrysotile (1)
	<b>Building</b>	<b>Room</b>	<b>Item</b>	<b>Quantity</b>	
	St Johns School	Office G08	Brown tiles and adhesive Floor	6m <sup>2</sup>	
	<b>Sample No (S,SP,P,As)</b>	<b>Product Type</b>	<b>Surface Treatment</b>	<b>Condition</b>	<b>Accessibility</b>
	AB005153* (S)	Reinforced Composite (1)	Completely Sealed (0)	Low Damage (1)	Usually inaccessible or unlikely to be disturbed
<b>Material Risk Score</b>					
3					
<b>Recommended action</b>	D - No Attention Required, Label				
<b>Surveyor comments</b>	Brown tiles and adhesive under carpet				
<b>Reinspection State</b>	No Change				
<b>Review Comments</b>	No change

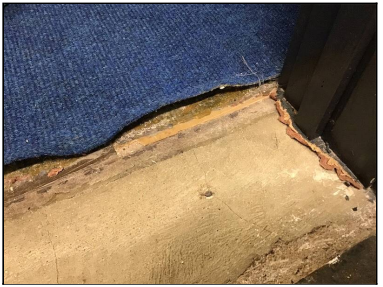
<b>Re-inspection Date:</b>	<b>Lead Surveyor</b>	<b>Survey Type</b>	<b>Floor</b>	<b>Analysis</b>
	23 May 2025	Matthew Monro	Reinspection Survey	Ground Floor	Chrysotile (1)
	<b>Building</b>	<b>Room</b>	<b>Item</b>	<b>Quantity</b>	
	St Johns School	Office G08	Cream tiles and adhesive Floor	6m <sup>2</sup>	
	<b>Sample No (S,SP,P,As)</b>	<b>Product Type</b>	<b>Surface Treatment</b>	<b>Condition</b>	<b>Accessibility</b>
	AB005154* (S)	Reinforced Composite (1)	Completely Sealed (0)	Good Condition (0)	Usually inaccessible or unlikely to be disturbed
<b>Material Risk Score</b>					
2					
<b>Recommended action</b>	D - No Attention Required, Label				
<b>Surveyor comments</b>	Cream tiles and adhesive under carpet				
<b>Reinspection State</b>	No Change				
<b>Review Comments</b>	No change

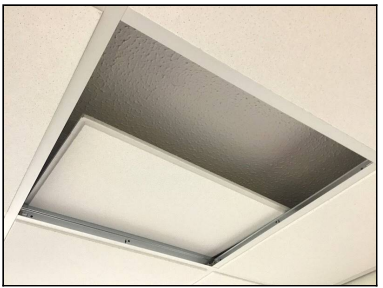
<b>Re-inspection Date:</b>	<b>Lead Surveyor</b>	<b>Survey Type</b>	<b>Floor</b>	<b>Analysis</b>
	23 May 2025	Matthew Monro	Reinspection Survey	Ground Floor	Chrysotile (1)
	<b>Building</b>	<b>Room</b>	<b>Item</b>	<b>Quantity</b>	
	St Johns School	Head teachers office G09	Textured coating Ceiling	17m <sup>2</sup>	
	<b>Sample No (S,SP,P,As)</b>	<b>Product Type</b>	<b>Surface Treatment</b>	<b>Condition</b>	<b>Accessibility</b>
	As AB005151* (SP)	Textured Coating (1)	Surface Sealed (1)	Good Condition (0)	Usually inaccessible or unlikely to be disturbed
<b>Material Risk Score</b>					
3					
<b>Recommended action</b>	D - No Attention Required, Label				
<b>Surveyor comments</b>	Textured coating to ceiling				
<b>Reinspection State</b>	No Change				
<b>Review Comments</b>	No change

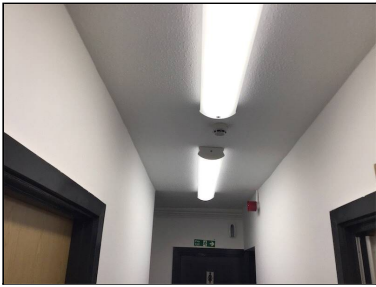
<b>Re-inspection Date:</b>	<b>Lead Surveyor</b>	<b>Survey Type</b>	<b>Floor</b>	<b>Analysis</b>
	23 May 2025	Matthew Monro	Reinspection Survey	Ground Floor	Chrysotile (1)
	<b>Building</b>	<b>Room</b>	<b>Item</b>	<b>Quantity</b>	
	St Johns School	Staff circulation G10	Textured coating Ceiling	10m <sup>2</sup>	
	<b>Sample No (S,SP,P,As)</b>	<b>Product Type</b>	<b>Surface Treatment</b>	<b>Condition</b>	<b>Accessibility</b>
	As AB005151* (SP)	Textured Coating (1)	Surface Sealed (1)	Good Condition (0)	Usually inaccessible or unlikely to be disturbed
	<b>Material Risk Score</b>				
3					
<b>Recommended action</b>	D - No Attention Required, Label				
<b>Surveyor comments</b>	Textured coating to ceiling				
<b>Reinspection State</b>	No Change				
<b>Review Comments</b>	No change

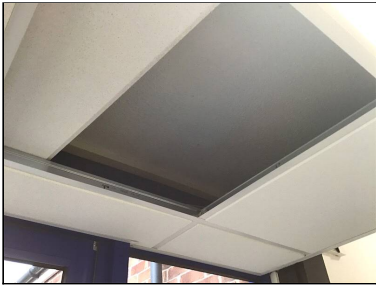
<b>Re-inspection Date:</b>	<b>Lead Surveyor</b>	<b>Survey Type</b>	<b>Floor</b>	<b>Analysis</b>
	23 May 2025	Matthew Monro	Reinspection Survey	Ground Floor	Chrysotile (1)
	<b>Building</b>	<b>Room</b>	<b>Item</b>	<b>Quantity</b>	
	St Johns School	Entrance G11	Textured coating Ceiling	20m <sup>2</sup>	
	<b>Sample No (S,SP,P,As)</b>	<b>Product Type</b>	<b>Surface Treatment</b>	<b>Condition</b>	<b>Accessibility</b>
	AB005155* (S)	Textured Coating (1)	Surface Sealed (1)	Good Condition (0)	Usually inaccessible or unlikely to be disturbed
	<b>Material Risk Score</b>				
3					
<b>Recommended action</b>	D - No Attention Required, Label				
<b>Surveyor comments</b>	Textured coating to ceiling				
<b>Reinspection State</b>	No Change				
<b>Review Comments</b>	No change

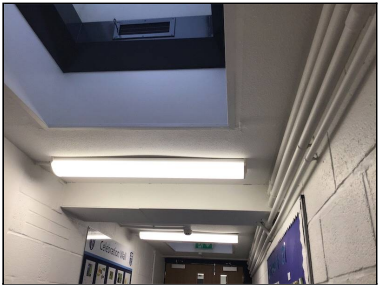
<b>Re-inspection Date:</b>	<b>Lead Surveyor</b>	<b>Survey Type</b>	<b>Floor</b>	<b>Analysis</b>
	23 May 2025	Matthew Monro	Reinspection Survey	Ground Floor	Chrysotile (1)
	<b>Building</b>	<b>Room</b>	<b>Item</b>	<b>Quantity</b>	
	St Johns School	Circulation G12	Textured coating Ceiling	17m <sup>2</sup>	
	<b>Sample No (S,SP,P,As)</b>	<b>Product Type</b>	<b>Surface Treatment</b>	<b>Condition</b>	<b>Accessibility</b>
	As AB005155* (SP)	Textured Coating (1)	Surface Sealed (1)	Good Condition (0)	Occasionally likely to be disturbed
	<b>Material Risk Score</b>				
3					
<b>Recommended action</b>	D - No Attention Required, Label				
<b>Surveyor comments</b>	Textured coating to ceiling				
<b>Reinspection State</b>	No Change				
<b>Review Comments</b>	No change

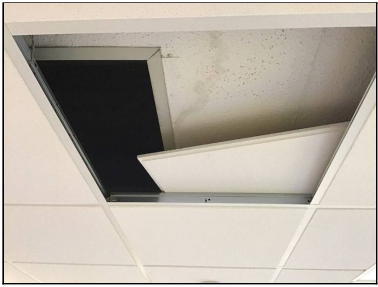
<b>Re-inspection Date:</b>	<b>Lead Surveyor</b>	<b>Survey Type</b>	<b>Floor</b>	<b>Analysis</b>
	23 May 2025	Matthew Monro	Reinspection Survey	Ground Floor	Chrysotile (1)
	<b>Building</b>	<b>Room</b>	<b>Item</b>	<b>Quantity</b>	
	St Johns School	Reception classroom G13	Textured coating Ceiling	120m <sup>2</sup>	
	<b>Sample No (S,SP,P,As)</b>	<b>Product Type</b>	<b>Surface Treatment</b>	<b>Condition</b>	<b>Accessibility</b>
	AB005156* (S)	Textured Coating (1)	Surface Sealed (1)	Good Condition (0)	Occasionally likely to be disturbed
	<b>Material Risk Score</b>				
3					
<b>Recommended action</b>	D - No Attention Required, Label				
<b>Surveyor comments</b>	Textured coating to ceiling				
<b>Reinspection State</b>	No Change				
<b>Review Comments</b>	No change

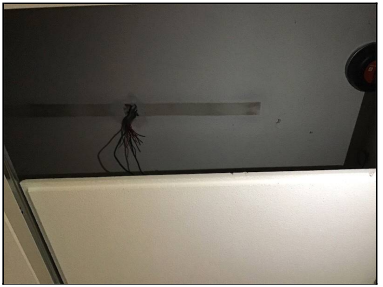
<b>Re-inspection Date:</b>	<b>Lead Surveyor</b>	<b>Survey Type</b>	<b>Floor</b>	<b>Analysis</b>
	23 May 2025	Matthew Monro	Reinspection Survey	Ground Floor	Chrysotile (1)
	<b>Building</b>	<b>Room</b>	<b>Item</b>	<b>Quantity</b>	
	St Johns School	Kitchen G14	Textured coating Ceiling	10m <sup>2</sup>	
	<b>Sample No (S,SP,P,As)</b>	<b>Product Type</b>	<b>Surface Treatment</b>	<b>Condition</b>	<b>Accessibility</b>
	As AB005156* (SP)	Textured Coating (1)	Surface Sealed (1)	Good Condition (0)	Occasionally likely to be disturbed
<b>Material Risk Score</b>					
3					
<b>Recommended action</b>	D - No Attention Required, Label				
<b>Surveyor comments</b>	Textured coating to ceiling				
<b>Reinspection State</b>					
<b>Review Comments</b>	No change

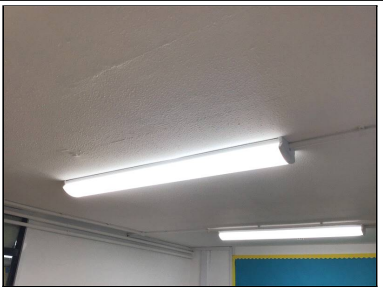
<b>Re-inspection Date:</b>	<b>Lead Surveyor</b>	<b>Survey Type</b>	<b>Floor</b>	<b>Analysis</b>
	23 May 2025	Matthew Monro	Reinspection Survey	Ground Floor	Chrysotile (1)
	<b>Building</b>	<b>Room</b>	<b>Item</b>	<b>Quantity</b>	
	St Johns School	Reception classroom 2 G15	Textured coating Ceiling	40m <sup>2</sup>	
	<b>Sample No (S,SP,P,As)</b>	<b>Product Type</b>	<b>Surface Treatment</b>	<b>Condition</b>	<b>Accessibility</b>
	As AB005156* (SP)	Textured Coating (1)	Surface Sealed (1)	Good Condition (0)	Occasionally likely to be disturbed
<b>Material Risk Score</b>					
3					
<b>Recommended action</b>	D - No Attention Required, Label				
<b>Surveyor comments</b>	Textured coating to ceiling				
<b>Reinspection State</b>	No Change				
<b>Review Comments</b>	No change

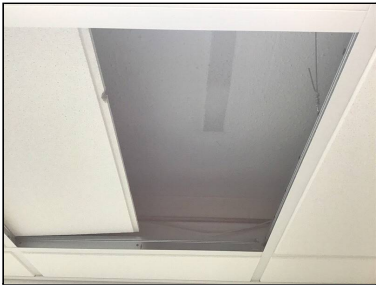
<b>Re-inspection Date:</b>	<b>Lead Surveyor</b>	<b>Survey Type</b>	<b>Floor</b>	<b>Analysis</b>
	23 May 2025	Matthew Monro	Reinspection Survey	Ground Floor	Chrysotile (1)
	<b>Building</b>	<b>Room</b>	<b>Item</b>	<b>Quantity</b>	
	St Johns School	Disabled toilet G16	Textured coating Ceiling	8m <sup>2</sup>	
	<b>Sample No (S,SP,P,As)</b>	<b>Product Type</b>	<b>Surface Treatment</b>	<b>Condition</b>	<b>Accessibility</b>
	As AB005156* (SP)	Textured Coating (1)	Surface Sealed (1)	Good Condition (0)	Usually inaccessible or unlikely to be disturbed
	<b>Material Risk Score</b>				
3					
<b>Recommended action</b>	D - No Attention Required, Label				
<b>Surveyor comments</b>	Textured coating to ceiling				
<b>Reinspection State</b>	No Change				
<b>Review Comments</b>	No change

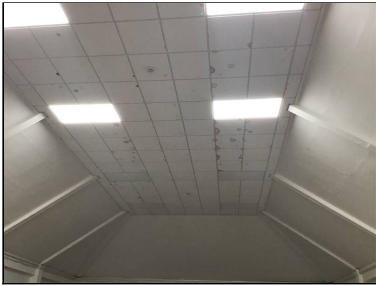
<b>Re-inspection Date:</b>	<b>Lead Surveyor</b>	<b>Survey Type</b>	<b>Floor</b>	<b>Analysis</b>
	23 May 2025	Matthew Monro	Reinspection Survey	Ground Floor	N/A
	<b>Building</b>	<b>Room</b>	<b>Item</b>	<b>Quantity</b>	
	St Johns School	School hall G18	Suspended ceiling	N/A	
	<b>Sample No (S,SP,P,As)</b>	<b>Product Type</b>	<b>Surface Treatment</b>	<b>Condition</b>	<b>Accessibility</b>
	Visual (P)	N/A	N/A	N/A	N/A
	<b>Material Risk Score</b>				
N/A					
<b>Recommended action</b>	Inspection Required				
<b>Surveyor comments</b>	No access above ceiling due to height				
<b>Reinspection State</b>	No Change				
<b>Review Comments</b>	No change

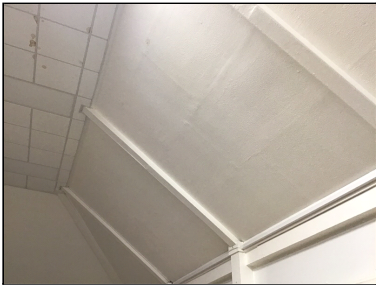
<b>Re-inspection Date:</b>	<b>Lead Surveyor</b>	<b>Survey Type</b>	<b>Floor</b>	<b>Analysis</b>
	23 May 2025	Matthew Monro	Reinspection Survey	Ground Floor	Chrysotile (1)
	<b>Building</b>	<b>Room</b>	<b>Item</b>	<b>Quantity</b>	
	St Johns School	School hall G18	Textured coating Pitched ceiling	250m <sup>2</sup>	
	<b>Sample No (S,SP,P,As)</b>	<b>Product Type</b>	<b>Surface Treatment</b>	<b>Condition</b>	<b>Accessibility</b>
	AB005157* (S)	Textured Coating (1)	Surface Sealed (1)	Good Condition (0)	Usually inaccessible or unlikely to be disturbed
	<b>Material Risk Score</b>				
3					
<b>Recommended action</b>	D - No Attention Required, Label				
<b>Surveyor comments</b>	Textured coating to pitched ceiling in hall				
<b>Reinspection State</b>	No Change				
<b>Review Comments</b>	No change

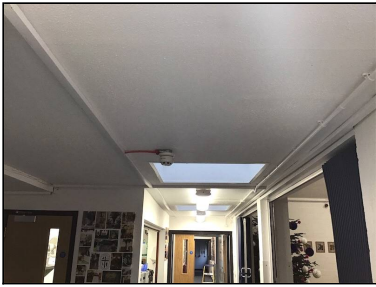
<b>Re-inspection Date:</b>	<b>Lead Surveyor</b>	<b>Survey Type</b>	<b>Floor</b>	<b>Analysis</b>
	23 May 2025	Matthew Monro	Reinspection Survey	Ground Floor	Chrysotile (1)
	<b>Building</b>	<b>Room</b>	<b>Item</b>	<b>Quantity</b>	
	St Johns School	Servery circulation G21	Textured coating Pitched ceiling	10m <sup>2</sup>	
	<b>Sample No (S,SP,P,As)</b>	<b>Product Type</b>	<b>Surface Treatment</b>	<b>Condition</b>	<b>Accessibility</b>
	As AB005157* (SP)	Textured Coating (1)	Surface Sealed (1)	Good Condition (0)	Occasionally likely to be disturbed
	<b>Material Risk Score</b>				
3					
<b>Recommended action</b>	D - No Attention Required, Label				
<b>Surveyor comments</b>	Textured coating to pitched ceiling in hall				
<b>Reinspection State</b>	No Change				
<b>Review Comments</b>	No change

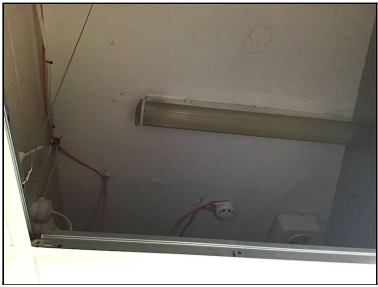
<b>Re-inspection Date:</b>	<b>Lead Surveyor</b>	<b>Survey Type</b>	<b>Floor</b>	<b>Analysis</b>
	23 May 2025	Matthew Monro	Reinspection Survey	Ground Floor	Chrysotile (1)
	<b>Building</b>	<b>Room</b>	<b>Item</b>	<b>Quantity</b>	
	St Johns School	Girls toilet G23	Textured coating Ceiling	6m <sup>2</sup>	
	<b>Sample No (S,SP,P,As)</b>	<b>Product Type</b>	<b>Surface Treatment</b>	<b>Condition</b>	<b>Accessibility</b>
	AB005158* (S)	Textured Coating + Well Bound Material (1)	Surface Sealed (1)	Good Condition (0)	Usually inaccessible or unlikely to be disturbed
<b>Material Risk Score</b>					
3					
<b>Recommended action</b>	D - No Attention Required, Label				
<b>Surveyor comments</b>	Textured coating to ceiling				
<b>Reinspection State</b>	No Change				
<b>Review Comments</b>	No change

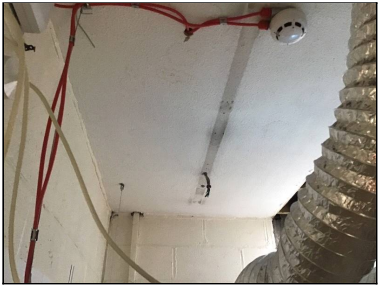
<b>Re-inspection Date:</b>	<b>Lead Surveyor</b>	<b>Survey Type</b>	<b>Floor</b>	<b>Analysis</b>
	23 May 2025	Matthew Monro	Reinspection Survey	Ground Floor	Chrysotile (1)
	<b>Building</b>	<b>Room</b>	<b>Item</b>	<b>Quantity</b>	
	St Johns School	Boys toilet G24	Textured coating Ceiling	6m <sup>2</sup>	
	<b>Sample No (S,SP,P,As)</b>	<b>Product Type</b>	<b>Surface Treatment</b>	<b>Condition</b>	<b>Accessibility</b>
	As AB005158* (SP)	Textured Coating + Well Bound Material (1)	Surface Sealed (1)	Good Condition (0)	Usually inaccessible or unlikely to be disturbed
<b>Material Risk Score</b>					
3					
<b>Recommended action</b>	D - No Attention Required, Label				
<b>Surveyor comments</b>	Textured coating to ceiling				
<b>Reinspection State</b>	No Change				
<b>Review Comments</b>	No change

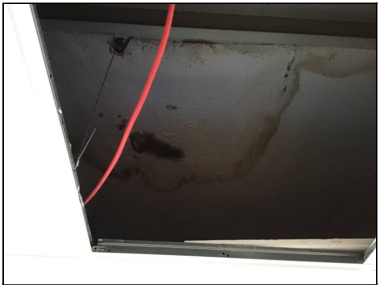
<b>Re-inspection Date:</b>	<b>Lead Surveyor</b>	<b>Survey Type</b>	<b>Floor</b>	<b>Analysis</b>
	23 May 2025	Matthew Monro	Reinspection Survey	Ground Floor	Chrysotile (1)
	<b>Building</b>	<b>Room</b>	<b>Item</b>	<b>Quantity</b>	
	St Johns School	Year 2 classroom G25	Textured coating Ceiling	62m <sup>2</sup>	
	<b>Sample No (S,SP,P,As)</b>	<b>Product Type</b>	<b>Surface Treatment</b>	<b>Condition</b>	<b>Accessibility</b>
	As AB005158* (SP)	Textured Coating + Well Bound Material (1)	Surface Sealed (1)	Low Damage (1)	Usually inaccessible or unlikely to be disturbed
<b>Material Risk Score</b>					
4					
<b>Recommended action</b>	B - Immediate Encapsulation				
<b>Surveyor comments</b>	Textured coating to ceiling				
<b>Reinspection State</b>	Damaged				
<b>Review Comments</b>	Small area of water damage in centre of ceiling, recommend removal of damaged area

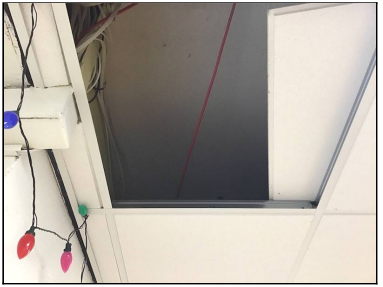
<b>Re-inspection Date:</b>	<b>Lead Surveyor</b>	<b>Survey Type</b>	<b>Floor</b>	<b>Analysis</b>
	23 May 2025	Matthew Monro	Reinspection Survey	Ground Floor	Chrysotile (1)
	<b>Building</b>	<b>Room</b>	<b>Item</b>	<b>Quantity</b>	
	St Johns School	Year 3 and 4 classroom G28	Textured coating Ceiling	55m <sup>2</sup>	
	<b>Sample No (S,SP,P,As)</b>	<b>Product Type</b>	<b>Surface Treatment</b>	<b>Condition</b>	<b>Accessibility</b>
	As AB005158* (SP)	Textured Coating + Well Bound Material (1)	Surface Sealed (1)	Good Condition (0)	Usually inaccessible or unlikely to be disturbed
<b>Material Risk Score</b>					
3					
<b>Recommended action</b>	D - No Attention Required, Label				
<b>Surveyor comments</b>	Textured coating to ceiling				
<b>Reinspection State</b>	No Change				
<b>Review Comments</b>	No change

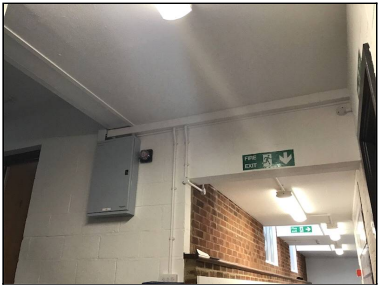
<b>Re-inspection Date:</b>	<b>Lead Surveyor</b>	<b>Survey Type</b>	<b>Floor</b>	<b>Analysis</b>
	23 May 2025	Matthew Monro	Reinspection Survey	Ground Floor	Chrysotile (1)
	<b>Building</b>	<b>Room</b>	<b>Item</b>	<b>Quantity</b>	
	St Johns School	Cloaks and circulation G29	Textured coating Ceiling	30m <sup>2</sup>	
	<b>Sample No (S,SP,P,As)</b>	<b>Product Type</b>	<b>Surface Treatment</b>	<b>Condition</b>	<b>Accessibility</b>
	As AB005158* (SP)	Textured Coating + Well Bound Material (1)	Surface Sealed (1)	Good Condition (0)	Usually inaccessible or unlikely to be disturbed
<b>Material Risk Score</b>					
	3				
<b>Recommended action</b>	D - No Attention Required, Label				
<b>Surveyor comments</b>	Textured coating to ceiling				
<b>Reinspection State</b>	No Change				
<b>Review Comments</b>	No change

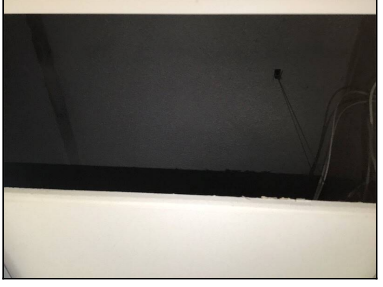
<b>Re-inspection Date:</b>	<b>Lead Surveyor</b>	<b>Survey Type</b>	<b>Floor</b>	<b>Analysis</b>
	23 May 2025	Matthew Monro	Reinspection Survey	Ground Floor	Chrysotile (1)
	<b>Building</b>	<b>Room</b>	<b>Item</b>	<b>Quantity</b>	
	St Johns School	Girls toilet G30	Textured coating Ceiling	8m <sup>2</sup>	
	<b>Sample No (S,SP,P,As)</b>	<b>Product Type</b>	<b>Surface Treatment</b>	<b>Condition</b>	<b>Accessibility</b>
	As AB005158* (SP)	Textured Coating + Well Bound Material (1)	Surface Sealed (1)	Good Condition (0)	Usually inaccessible or unlikely to be disturbed
<b>Material Risk Score</b>					
	3				
<b>Recommended action</b>	D - No Attention Required, Label				
<b>Surveyor comments</b>	Textured coating to ceiling				
<b>Reinspection State</b>	No Change				
<b>Review Comments</b>	No change

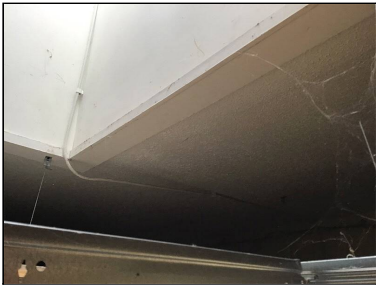
<b>Re-inspection Date:</b>	<b>Lead Surveyor</b>	<b>Survey Type</b>	<b>Floor</b>	<b>Analysis</b>
	23 May 2025	Matthew Monro	Reinspection Survey	Ground Floor	Chrysotile (1)
	<b>Building</b>	<b>Room</b>	<b>Item</b>	<b>Quantity</b>	
	St Johns School	Year 12 classroom G31	Textured coating Ceiling	75m <sup>2</sup>	
	<b>Sample No (S,SP,P,As)</b>	<b>Product Type</b>	<b>Surface Treatment</b>	<b>Condition</b>	<b>Accessibility</b>
	As AB005158* (SP)	Textured Coating + Well Bound Material (1)	Surface Sealed (1)	Good Condition (0)	Usually inaccessible or unlikely to be disturbed
<b>Material Risk Score</b>					
3					
<b>Recommended action</b>	D - No Attention Required, Label				
<b>Surveyor comments</b>	Textured coating to ceiling				
<b>Reinspection State</b>	No Change				
<b>Review Comments</b>	No change

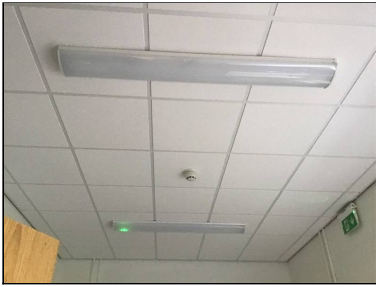
<b>Re-inspection Date:</b>	<b>Lead Surveyor</b>	<b>Survey Type</b>	<b>Floor</b>	<b>Analysis</b>
	23 May 2025	Matthew Monro	Reinspection Survey	Ground Floor	Chrysotile (1)
	<b>Building</b>	<b>Room</b>	<b>Item</b>	<b>Quantity</b>	
	St Johns School	SENDco room G32	Textured coating Ceiling	18m <sup>2</sup>	
	<b>Sample No (S,SP,P,As)</b>	<b>Product Type</b>	<b>Surface Treatment</b>	<b>Condition</b>	<b>Accessibility</b>
	As AB005158* (SP)	Textured Coating + Well Bound Material (1)	Surface Sealed (1)	Good Condition (0)	Usually inaccessible or unlikely to be disturbed
<b>Material Risk Score</b>					
3					
<b>Recommended action</b>	D - No Attention Required, Label				
<b>Surveyor comments</b>	Textured coating to ceiling				
<b>Reinspection State</b>	No Change				
<b>Review Comments</b>	No change

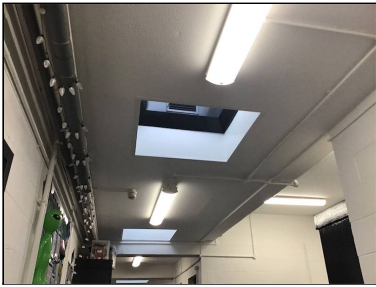
<b>Re-inspection Date:</b>	<b>Lead Surveyor</b>	<b>Survey Type</b>	<b>Floor</b>	<b>Analysis</b>
	23 May 2025	Matthew Monro	Reinspection Survey	Ground Floor	Chrysotile (1)
	<b>Building</b>	<b>Room</b>	<b>Item</b>	<b>Quantity</b>	
	St Johns School	Circulation G33	Textured coating Ceiling	30m <sup>2</sup>	
	<b>Sample No (S,SP,P,As)</b>	<b>Product Type</b>	<b>Surface Treatment</b>	<b>Condition</b>	<b>Accessibility</b>
	As AB005158* (SP)	Textured Coating + Well Bound Material (1)	Surface Sealed (1)	Good Condition (0)	Usually inaccessible or unlikely to be disturbed
<b>Material Risk Score</b>					
	3				
<b>Recommended action</b>	D - No Attention Required, Label				
<b>Surveyor comments</b>	Textured coating to ceiling				
<b>Reinspection State</b>	No Change				
<b>Review Comments</b>	No change

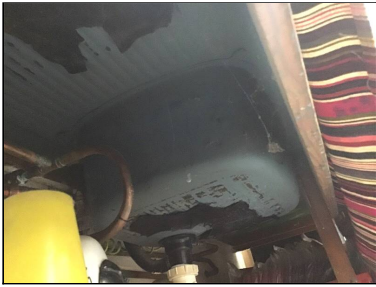
<b>Re-inspection Date:</b>	<b>Lead Surveyor</b>	<b>Survey Type</b>	<b>Floor</b>	<b>Analysis</b>
	23 May 2025	Matthew Monro	Reinspection Survey	Ground Floor	Chrysotile (1)
	<b>Building</b>	<b>Room</b>	<b>Item</b>	<b>Quantity</b>	
	St Johns School	Circulation G33	Acoustic pads Sink	2m <sup>2</sup>	
	<b>Sample No (S,SP,P,As)</b>	<b>Product Type</b>	<b>Surface Treatment</b>	<b>Condition</b>	<b>Accessibility</b>
	AB005159* (S)	Reinforced Composite (1)	Completely Sealed (0)	Low Damage (1)	Usually inaccessible or unlikely to be disturbed
<b>Material Risk Score</b>					
	3				
<b>Recommended action</b>	D - No Attention Required, Label				
<b>Surveyor comments</b>	Acoustic pads to underside of sink unit				
<b>Reinspection State</b>	No Change				
<b>Review Comments</b>	No change

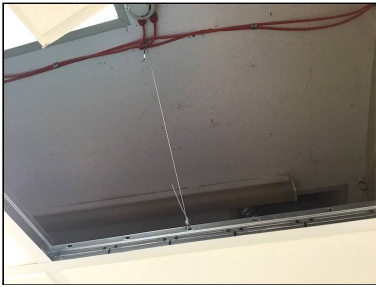
<b>Re-inspection Date:</b>	<b>Lead Surveyor</b>	<b>Survey Type</b>	<b>Floor</b>	<b>Analysis</b>
	23 May 2025	Matthew Monro	Reinspection Survey	Ground Floor	Chrysotile (1)
	<b>Building</b>	<b>Room</b>	<b>Item</b>	<b>Quantity</b>	
	St Johns School	Boys toilet G34	Textured coating Ceiling	8m <sup>2</sup>	
	<b>Sample No (S,SP,P,As)</b>	<b>Product Type</b>	<b>Surface Treatment</b>	<b>Condition</b>	<b>Accessibility</b>
	As AB005158* (SP)	Textured Coating + Well Bound Material (1)	Surface Sealed (1)	Good Condition (0)	Usually inaccessible or unlikely to be disturbed
<b>Material Risk Score</b>					
3					
<b>Recommended action</b>	D - No Attention Required, Label				
<b>Surveyor comments</b>	Textured coating to ceiling				
<b>Reinspection State</b>	No Change				
<b>Review Comments</b>	No change

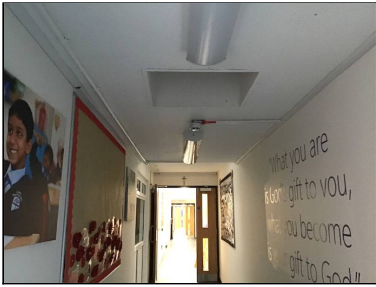
<b>Re-inspection Date:</b>	<b>Lead Surveyor</b>	<b>Survey Type</b>	<b>Floor</b>	<b>Analysis</b>
	23 May 2025	Matthew Monro	Reinspection Survey	Ground Floor	Chrysotile (1)
	<b>Building</b>	<b>Room</b>	<b>Item</b>	<b>Quantity</b>	
	St Johns School	Circulation G43	Textured coating Ceiling	20m <sup>2</sup>	
	<b>Sample No (S,SP,P,As)</b>	<b>Product Type</b>	<b>Surface Treatment</b>	<b>Condition</b>	<b>Accessibility</b>
	AB005161* (S)	Textured Coating (1)	Surface Sealed (1)	Good Condition (0)	Occasionally likely to be disturbed
<b>Material Risk Score</b>					
3					
<b>Recommended action</b>	D - No Attention Required, Label				
<b>Surveyor comments</b>	Textured coating to ceiling				
<b>Reinspection State</b>	No Change				
<b>Review Comments</b>	No change

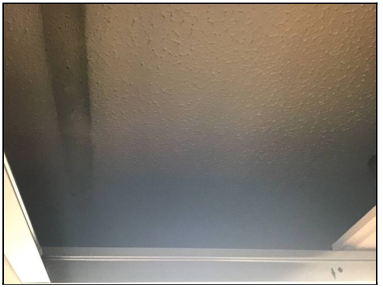
<b>Re-inspection Date:</b>	<b>Lead Surveyor</b>	<b>Survey Type</b>	<b>Floor</b>	<b>Analysis</b>
	23 May 2025	Matthew Monro	Reinspection Survey	Ground Floor	Chrysotile (1)
	<b>Building</b>	<b>Room</b>	<b>Item</b>	<b>Quantity</b>	
	St Johns School	Year 4 classroom G44	Textured coating Ceiling	60m <sup>2</sup>	
	<b>Sample No (S,SP,P,As)</b>	<b>Product Type</b>	<b>Surface Treatment</b>	<b>Condition</b>	<b>Accessibility</b>
	As AB005161* (SP)	Textured Coating (1)	Surface Sealed (1)	Good Condition (0)	Usually inaccessible or unlikely to be disturbed
	<b>Material Risk Score</b>				
3					
<b>Recommended action</b>	D - No Attention Required, Label				
<b>Surveyor comments</b>	Textured coating to ceiling				
<b>Reinspection State</b>	No Change				
<b>Review Comments</b>	No change

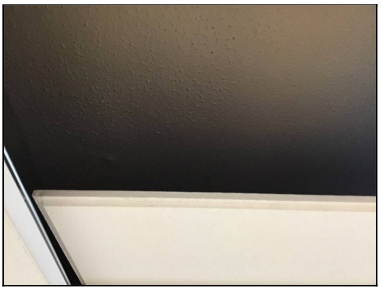
<b>Re-inspection Date:</b>	<b>Lead Surveyor</b>	<b>Survey Type</b>	<b>Floor</b>	<b>Analysis</b>
	23 May 2025	Matthew Monro	Reinspection Survey	Ground Floor	Chrysotile (1)
	<b>Building</b>	<b>Room</b>	<b>Item</b>	<b>Quantity</b>	
	St Johns School	Library G45	Textured coating Ceiling	60m <sup>2</sup>	
	<b>Sample No (S,SP,P,As)</b>	<b>Product Type</b>	<b>Surface Treatment</b>	<b>Condition</b>	<b>Accessibility</b>
	As AB005161* (SP)	Textured Coating (1)	Surface Sealed (1)	Good Condition (0)	Usually inaccessible or unlikely to be disturbed
	<b>Material Risk Score</b>				
3					
<b>Recommended action</b>	D - No Attention Required, Label				
<b>Surveyor comments</b>	Textured coating to ceiling				
<b>Reinspection State</b>	No Change				
<b>Review Comments</b>	No change

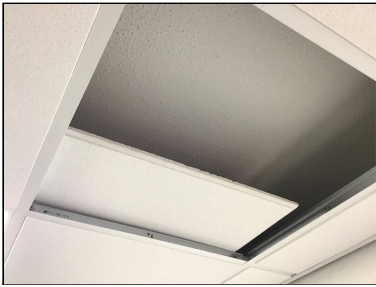
<b>Re-inspection Date:</b>	<b>Lead Surveyor</b>	<b>Survey Type</b>	<b>Floor</b>	<b>Analysis</b>
	23 May 2025	Matthew Monro	Reinspection Survey	Ground Floor	Chrysotile (1)
	<b>Building</b>	<b>Room</b>	<b>Item</b>	<b>Quantity</b>	
	St Johns School	Staff room G46	Textured coating Ceiling	30m <sup>2</sup>	
	<b>Sample No (S,SP,P,As)</b>	<b>Product Type</b>	<b>Surface Treatment</b>	<b>Condition</b>	<b>Accessibility</b>
	As AB005161* (SP)	Textured Coating (1)	Surface Sealed (1)	Good Condition (0)	Usually inaccessible or unlikely to be disturbed
<b>Material Risk Score</b>					
3					
<b>Recommended action</b>	D - No Attention Required, Label				
<b>Surveyor comments</b>	Textured coating to lower section of ceiling				
<b>Reinspection State</b>	No Change				
<b>Review Comments</b>	No change

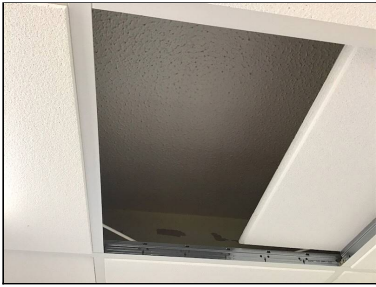
<b>Re-inspection Date:</b>	<b>Lead Surveyor</b>	<b>Survey Type</b>	<b>Floor</b>	<b>Analysis</b>
	23 May 2025	Matthew Monro	Reinspection Survey	Ground Floor	Chrysotile (1)
	<b>Building</b>	<b>Room</b>	<b>Item</b>	<b>Quantity</b>	
	St Johns School	Cloaks G47	Textured coating Ceiling	8m <sup>2</sup>	
	<b>Sample No (S,SP,P,As)</b>	<b>Product Type</b>	<b>Surface Treatment</b>	<b>Condition</b>	<b>Accessibility</b>
	As AB005161* (SP)	Textured Coating (1)	Surface Sealed (1)	Good Condition (0)	Usually inaccessible or unlikely to be disturbed
<b>Material Risk Score</b>					
3					
<b>Recommended action</b>	D - No Attention Required, Label				
<b>Surveyor comments</b>	Textured coating to lower section of ceiling				
<b>Reinspection State</b>	No Change				
<b>Review Comments</b>	No change

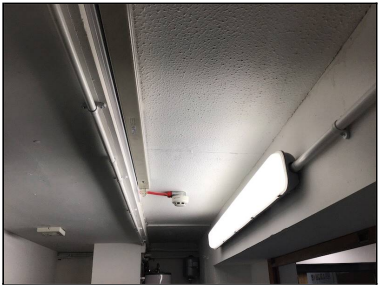
<b>Re-inspection Date:</b>	<b>Lead Surveyor</b>	<b>Survey Type</b>	<b>Floor</b>	<b>Analysis</b>
	23 May 2025	Matthew Monro	Reinspection Survey	Ground Floor	Chrysotile (1)
	<b>Building</b>	<b>Room</b>	<b>Item</b>	<b>Quantity</b>	
	St Johns School	Kitchen G48	Textured coating Ceiling	4m <sup>2</sup>	
	<b>Sample No (S,SP,P,As)</b>	<b>Product Type</b>	<b>Surface Treatment</b>	<b>Condition</b>	<b>Accessibility</b>
	As AB005161* (SP)	Textured Coating (1)	Surface Sealed (1)	Good Condition (0)	Occasionally likely to be disturbed
<b>Material Risk Score</b>					
	3				
<b>Recommended action</b>	D - No Attention Required, Label				
<b>Surveyor comments</b>	Textured coating to ceiling				
<b>Reinspection State</b>	No Change				
<b>Review Comments</b>	No change

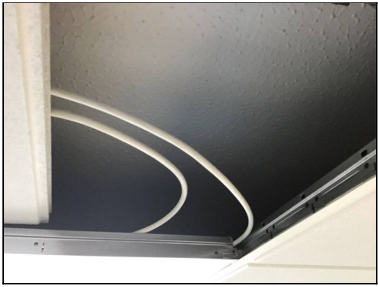
<b>Re-inspection Date:</b>	<b>Lead Surveyor</b>	<b>Survey Type</b>	<b>Floor</b>	<b>Analysis</b>
	23 May 2025	Matthew Monro	Reinspection Survey	Ground Floor	Chrysotile (1)
	<b>Building</b>	<b>Room</b>	<b>Item</b>	<b>Quantity</b>	
	St Johns School	Breakfast club G49	Textured coating Ceiling	48m <sup>2</sup>	
	<b>Sample No (S,SP,P,As)</b>	<b>Product Type</b>	<b>Surface Treatment</b>	<b>Condition</b>	<b>Accessibility</b>
	AB005162* (S)	Textured Coating (1)	Surface Sealed (1)	Good Condition (0)	Usually inaccessible or unlikely to be disturbed
<b>Material Risk Score</b>					
	3				
<b>Recommended action</b>	D - No Attention Required, Label				
<b>Surveyor comments</b>	Textured coating to ceiling				
<b>Reinspection State</b>	No Change				
<b>Review Comments</b>	No change

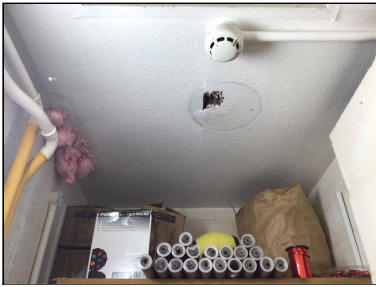
<b>Re-inspection Date:</b>	<b>Lead Surveyor</b>	<b>Survey Type</b>	<b>Floor</b>	<b>Analysis</b>
	23 May 2025	Matthew Monro	Reinspection Survey	Ground Floor	Chrysotile (1)
	<b>Building</b>	<b>Room</b>	<b>Item</b>	<b>Quantity</b>	
	St Johns School	Gas cupboard G50	Textured coating Ceiling	2m <sup>2</sup>	
	<b>Sample No (S,SP,P,As)</b>	<b>Product Type</b>	<b>Surface Treatment</b>	<b>Condition</b>	<b>Accessibility</b>
	As AB005162* (SP)	Textured Coating (1)	Surface Sealed (1)	Good Condition (0)	Usually inaccessible or unlikely to be disturbed
	<b>Material Risk Score</b>				
3					
<b>Recommended action</b>	D - No Attention Required, Label				
<b>Surveyor comments</b>	Textured coating to ceiling				
<b>Reinspection State</b>	No Change				
<b>Review Comments</b>	No change

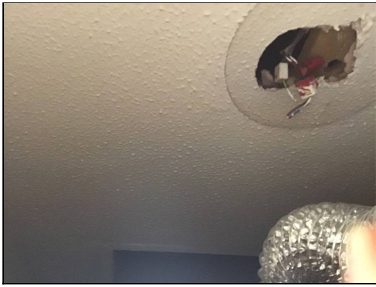
<b>Re-inspection Date:</b>	<b>Lead Surveyor</b>	<b>Survey Type</b>	<b>Floor</b>	<b>Analysis</b>
	23 May 2025	Matthew Monro	Reinspection Survey	Ground Floor	Chrysotile (1)
	<b>Building</b>	<b>Room</b>	<b>Item</b>	<b>Quantity</b>	
	St Johns School	Toilet G51	Textured coating Ceiling	2m <sup>2</sup>	
	<b>Sample No (S,SP,P,As)</b>	<b>Product Type</b>	<b>Surface Treatment</b>	<b>Condition</b>	<b>Accessibility</b>
	As AB005162* (SP)	Textured Coating (1)	Surface Sealed (1)	Good Condition (0)	Usually inaccessible or unlikely to be disturbed
	<b>Material Risk Score</b>				
3					
<b>Recommended action</b>	D - No Attention Required, Label				
<b>Surveyor comments</b>	Textured coating to ceiling				
<b>Reinspection State</b>	No Change				
<b>Review Comments</b>	No change

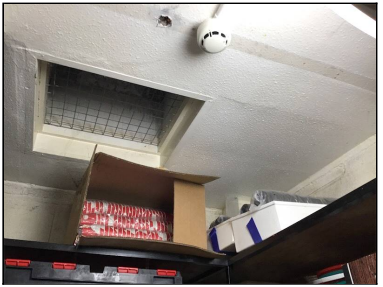
<b>Re-inspection Date:</b>	<b>Lead Surveyor</b>	<b>Survey Type</b>	<b>Floor</b>	<b>Analysis</b>
	23 May 2025	Matthew Monro	Reinspection Survey	Ground Floor	Chrysotile (1)
	<b>Building</b>	<b>Room</b>	<b>Item</b>	<b>Quantity</b>	
	St Johns School	Store G52	Textured coating Ceiling	4m <sup>2</sup>	
	<b>Sample No (S,SP,P,As)</b>	<b>Product Type</b>	<b>Surface Treatment</b>	<b>Condition</b>	<b>Accessibility</b>
	As AB005162* (SP)	Textured Coating (1)	Surface Sealed (1)	Good Condition (0)	Usually inaccessible or unlikely to be disturbed
	<b>Material Risk Score</b>				
3					
<b>Recommended action</b>	D - No Attention Required, Label				
<b>Surveyor comments</b>	Textured coating to ceiling				
<b>Reinspection State</b>	No Change				
<b>Review Comments</b>	No change

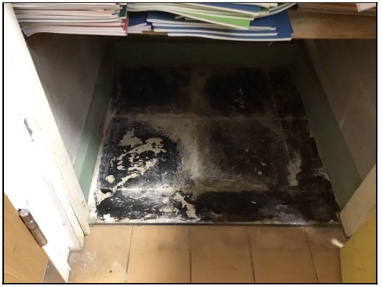
<b>Re-inspection Date:</b>	<b>Lead Surveyor</b>	<b>Survey Type</b>	<b>Floor</b>	<b>Analysis</b>
	23 May 2025	Matthew Monro	Reinspection Survey	Ground Floor	Chrysotile (1)
	<b>Building</b>	<b>Room</b>	<b>Item</b>	<b>Quantity</b>	
	St Johns School	Cupboard G53	White tiles and adhesive Floor	1m <sup>2</sup>	
	<b>Sample No (S,SP,P,As)</b>	<b>Product Type</b>	<b>Surface Treatment</b>	<b>Condition</b>	<b>Accessibility</b>
	AB005163* (S)	Reinforced Composite (1)	Completely Sealed (0)	Low Damage (1)	Easily disturbed
	<b>Material Risk Score</b>				
3					
<b>Recommended action</b>	D - No Attention Required, Label				
<b>Surveyor comments</b>	White floor tiles and adhesive in cupboard				
<b>Reinspection State</b>	Updated				
<b>Review Comments</b>	Tiles have been removed, bitumen remains to floor

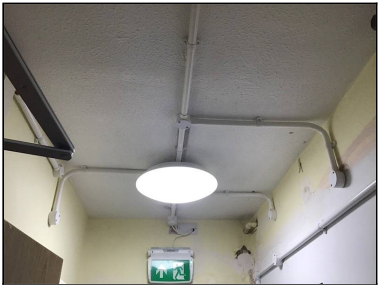
<b>Re-inspection Date:</b>	<b>Lead Surveyor</b>	<b>Survey Type</b>	<b>Floor</b>	<b>Analysis</b>
	23 May 2025	Matthew Monro	Reinspection Survey	Ground Floor	Chrysotile (1)
	<b>Building</b>	<b>Room</b>	<b>Item</b>	<b>Quantity</b>	
	St Johns School	Lobby G54	Textured coating Ceiling	3m <sup>2</sup>	
	<b>Sample No (S,SP,P,As)</b>	<b>Product Type</b>	<b>Surface Treatment</b>	<b>Condition</b>	<b>Accessibility</b>
	As AB005162* (SP)	Textured Coating (1)	Surface Sealed (1)	Good Condition (0)	Usually inaccessible or unlikely to be disturbed
	<b>Material Risk Score</b>				
3					
<b>Recommended action</b>	D - No Attention Required, Label				
<b>Surveyor comments</b>	Textured coating to ceiling				
<b>Reinspection State</b>	No Change				
<b>Review Comments</b>	No change

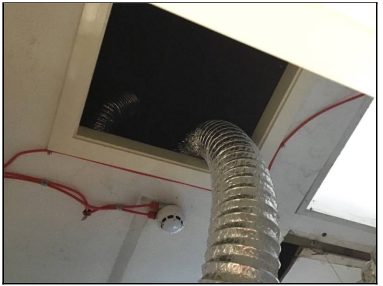
<b>Re-inspection Date:</b>	<b>Lead Surveyor</b>	<b>Survey Type</b>	<b>Floor</b>	<b>Analysis</b>
	23 May 2025	Matthew Monro	Reinspection Survey	Roof Void	N/A
	<b>Building</b>	<b>Room</b>	<b>Item</b>	<b>Quantity</b>	
	St Johns School	Boys toilet loft space R02	Inaccessible	N/A	
	<b>Sample No (S,SP,P,As)</b>	<b>Product Type</b>	<b>Surface Treatment</b>	<b>Condition</b>	<b>Accessibility</b>
	Visual (P)	N/A	N/A	N/A	N/A
	<b>Material Risk Score</b>				
N/A					
<b>Recommended action</b>	Inspection Required				
<b>Surveyor comments</b>	No access into loft space due to suspended ceiling.				
<b>Reinspection State</b>	No Change				
<b>Review Comments</b>	No change

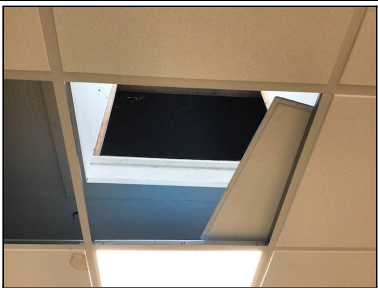
<b>Re-inspection Date:</b>	<b>Lead Surveyor</b>	<b>Survey Type</b>	<b>Floor</b>	<b>Analysis</b>
	23 May 2025	Matthew Monro	Reinspection Survey	Roof Void	N/A
	<b>Building</b>	<b>Room</b>	<b>Item</b>	<b>Quantity</b>	
	St Johns School	Year 12 classroom loft space R03	Inaccessible	N/A	
	<b>Sample No (S,SP,P,As)</b>	<b>Product Type</b>	<b>Surface Treatment</b>	<b>Condition</b>	<b>Accessibility</b>
	Visual (P)	N/A	N/A	N/A	N/A
	<b>Material Risk Score</b>				
N/A					
<b>Recommended action</b>	Inspection Required				
<b>Surveyor comments</b>	No access into loft space due to suspended ceiling				
<b>Reinspection State</b>	No Change				
<b>Review Comments</b>	No change
