Management Survey

St. Johns Rc School
Avocet Way
Banbury
Oxfordshire
OX16 9YA

Amity

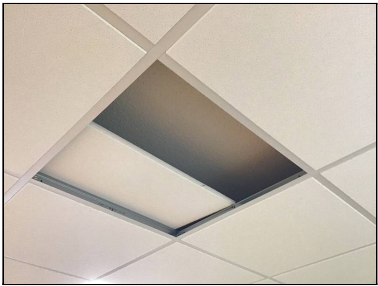
Survey Date:	Lead Surveyor	Survey Type	Floor	Analysis
	21 Dec 2022	Matthew Monro	Management Survey	Ground Floor	No Asbestos Detected (0)
	Building	Room	Item	Quantity	
	St Johns School	Year 5 and 6 classroom G36	Textured coating Ceiling	63m ²	
	Sample No (S,SP,P,As)	Product Type	Surface Treatment	Condition	Accessibility
	AB005160 (S)	Textured Coating (1)	Surface Sealed (1)	Good Condition (0)	Usually inaccessible or unlikely to be disturbed
	Material Risk Score				
Recommended action		No further action required			
Surveyor comments		Textured coating to ceiling

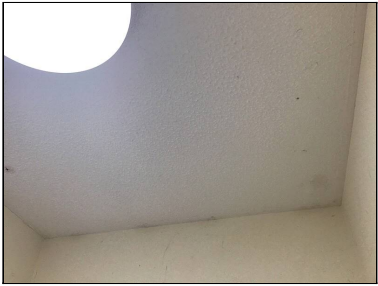
Survey Date:	Lead Surveyor	Survey Type	Floor	Analysis
	21 Dec 2022	Matthew Monro	Management Survey	Ground Floor	No Asbestos Detected (0)
	Building	Room	Item	Quantity	
	St Johns School	Year 5 and 6 classroom store G37	Textured coating Ceiling	3m ²	
	Sample No (S,SP,P,As)	Product Type	Surface Treatment	Condition	Accessibility
	As AB005160 (SP)	Textured Coating (1)	Surface Sealed (1)	Good Condition (0)	Usually inaccessible or unlikely to be disturbed
	Material Risk Score				
Recommended action		No further action required			
Surveyor comments		Textured coating to ceiling

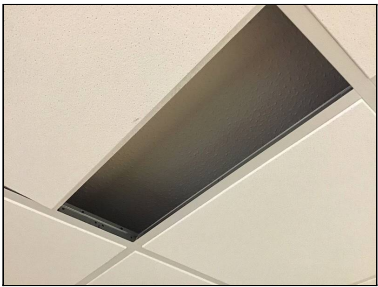
Survey Date:	Lead Surveyor	Survey Type	Floor	Analysis
	21 Dec 2022	Matthew Monro	Management Survey	Ground Floor	No Asbestos Detected (0)
	Building	Room	Item	Quantity	
	St Johns School	Year 6 classroom G38	Textured coating Ceiling	63m ²	
	Sample No (S,SP,P,As)	Product Type	Surface Treatment	Condition	Accessibility
	As AB005160 (SP)	Textured Coating (1)	Surface Sealed (1)	Good Condition (0)	Usually inaccessible or unlikely to be disturbed
	Material Risk Score				
Recommended action		No further action required			
Surveyor comments		Textured coating to ceiling

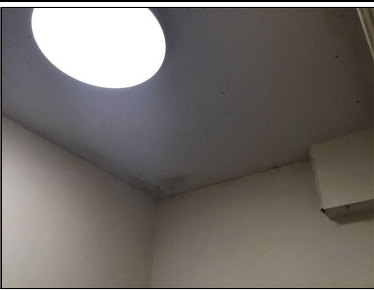
Survey Date:	Lead Surveyor	Survey Type	Floor	Analysis
	21 Dec 2022	Matthew Monro	Management Survey	Ground Floor	No Asbestos Detected (0)
	Building	Room	Item	Quantity	
	St Johns School	Year 6 classroom store G39	Textured coating Ceiling	3m²	
	Sample No (S,SP,P,As)	Product Type	Surface Treatment	Condition	Accessibility
	As AB005160 (SP)	Textured Coating (1)	Surface Sealed (1)	Good Condition (0)	Usually inaccessible or unlikely to be disturbed
		Material Risk Score			
	N/A				
Recommended action	No further action required				
Surveyor comments	Textured coating to ceiling

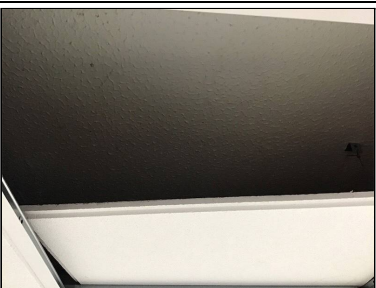
Survey Date:	Lead Surveyor	Survey Type	Floor	Analysis
	21 Dec 2022	Matthew Monro	Management Survey	Ground Floor	No Asbestos Detected (0)
	Building	Room	Item	Quantity	
	St Johns School	Boys toilet G40	Textured coating Ceiling	12m²	
	Sample No (S,SP,P,As)	Product Type	Surface Treatment	Condition	Accessibility
	As AB005160 (SP)	Textured Coating (1)	Surface Sealed (1)	Good Condition (0)	Usually inaccessible or unlikely to be disturbed
	Material Risk Score				
N/A					
Recommended action	No further action required				
Surveyor comments	Textured coating to ceiling

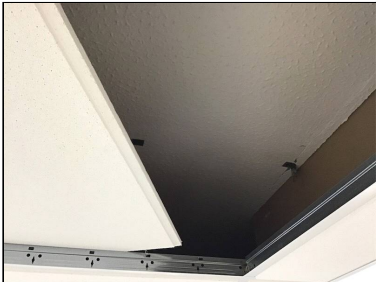
Survey Date:	Lead Surveyor	Survey Type	Floor	Analysis
	21 Dec 2022	Matthew Monro	Management Survey	Ground Floor	No Asbestos Detected (0)
	Building	Room	Item	Quantity	
	St Johns School	Girls toilet G41	Textured coating Ceiling	12m ²	
	Sample No (S,SP,P,As)	Product Type	Surface Treatment	Condition	Accessibility
	As AB005160 (SP)	Textured Coating (1)	Surface Sealed (1)	Good Condition (0)	Usually inaccessible or unlikely to be disturbed
	Material Risk Score				
Recommended action		No further action required			
Surveyor comments		Textured coating to ceiling

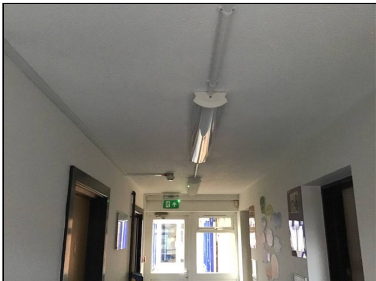
Survey Date:	Lead Surveyor	Survey Type	Floor	Analysis
	21 Dec 2022	Matthew Monro	Management Survey	Ground Floor	No Asbestos Detected (0)
	Building	Room	Item	Quantity	
	St Johns School	Toilet and classroom circulation G42	Textured coating Ceiling	14m ²	
	Sample No (S,SP,P,As)	Product Type	Surface Treatment	Condition	Accessibility
	As AB005160 (SP)	Textured Coating (1)	Surface Sealed (1)	Good Condition (0)	Usually inaccessible or unlikely to be disturbed
	Material Risk Score				
Recommended action		No further action required			
Surveyor comments		Textured coating to ceiling

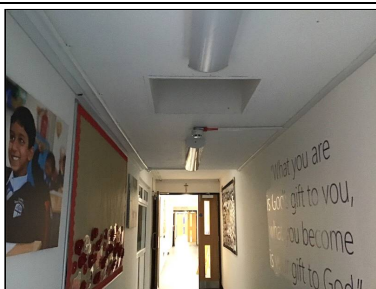
Survey Date:	Lead Surveyor	Survey Type	Floor	Analysis
	21 Dec 2022	Matthew Monro	Management Survey	Ground Floor	Chrysotile (1)
	Building	Room	Item	Quantity	
	St Johns School	Circulation G43	Textured coating Ceiling	20m²	
	Sample No (S,SP,P,As)	Product Type	Surface Treatment	Condition	Accessibility
	AB005161 (S)	Textured Coating (1)	Surface Sealed (1)	Good Condition (0)	Occasionally likely to be disturbed
	Material Risk Score				
	3				
Recommended action	D - No Attention Required, Label				
Surveyor comments	Textured coating to ceiling

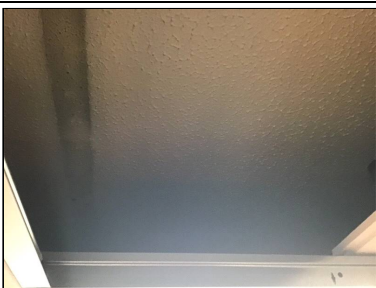
Survey Date:	Lead Surveyor	Survey Type	Floor	Analysis
	21 Dec 2022	Matthew Monro	Management Survey	Ground Floor	Chrysotile (1)
	Building	Room	Item	Quantity	
	St Johns School	Year 4 classroom G44	Textured coating Ceiling	60m²	
	Sample No (S,SP,P,As)	Product Type	Surface Treatment	Condition	Accessibility
	As AB005161 (SP)	Textured Coating (1)	Surface Sealed (1)	Good Condition (0)	Usually inaccessible or unlikely to be disturbed
	Material Risk Score				
	3				
Recommended action	D - No Attention Required, Label				
Surveyor comments	Textured coating to ceiling

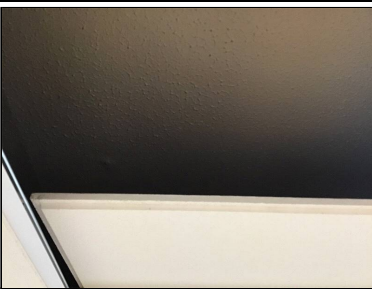
Survey Date:	Lead Surveyor	Survey Type	Floor	Analysis
	21 Dec 2022	Matthew Monro	Management Survey	Ground Floor	Chrysotile (1)
	Building	Room	Item	Quantity	
	St Johns School	Library G45	Textured coating Ceiling	60m²	
	Sample No (S,SP,P,As)	Product Type	Surface Treatment	Condition	Accessibility
	As AB005161 (SP)	Textured Coating (1)	Surface Sealed (1)	Good Condition (0)	Usually inaccessible or unlikely to be disturbed
	Material Risk Score				
	3				
Recommended action	D - No Attention Required, Label				
Surveyor comments	Textured coating to ceiling

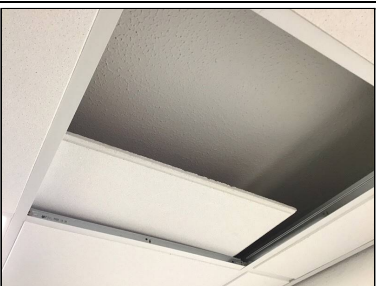
Survey Date:	Lead Surveyor	Survey Type	Floor	Analysis
	21 Dec 2022	Matthew Monro	Management Survey	Ground Floor	Chrysotile (1)
	Building	Room	Item	Quantity	
	St Johns School	Staff room G46	Textured coating Ceiling	30m²	
	Sample No (S,SP,P,As)	Product Type	Surface Treatment	Condition	Accessibility
	As AB005161 (SP)	Textured Coating (1)	Surface Sealed (1)	Good Condition (0)	Usually inaccessible or unlikely to be disturbed
	Material Risk Score				
3					
Recommended action	D - No Attention Required, Label				
Surveyor comments	Textured coating to lower section of ceiling

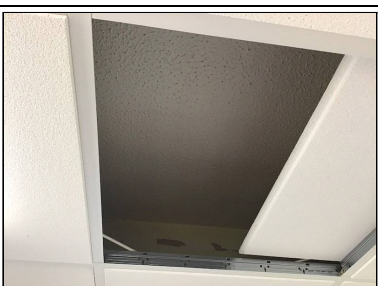
Survey Date:	Lead Surveyor	Survey Type	Floor	Analysis
	21 Dec 2022	Matthew Monro	Management Survey	Ground Floor	Chrysotile (1)
	Building	Room	Item	Quantity	
	St Johns School	Cloaks G47	Textured coating Ceiling	8m²	
	Sample No (S,SP,P,As)	Product Type	Surface Treatment	Condition	Accessibility
	As AB005161 (SP)	Textured Coating (1)	Surface Sealed (1)	Good Condition (0)	Usually inaccessible or unlikely to be disturbed
	Material Risk Score				
	3				
Recommended action	D - No Attention Required, Label				
Surveyor comments	Textured coating to lower section of ceiling

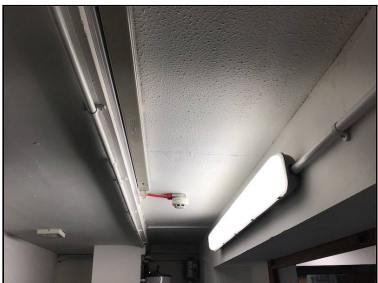
Survey Date:	Lead Surveyor	Survey Type	Floor	Analysis
	21 Dec 2022	Matthew Monro	Management Survey	Ground Floor	Chrysotile (1)
	Building	Room	Item	Quantity	
	St Johns School	Kitchen G48	Textured coating Ceiling	4m²	
	Sample No (S,SP,P,As)	Product Type	Surface Treatment	Condition	Accessibility
	As AB005161 (SP)	Textured Coating (1)	Surface Sealed (1)	Good Condition (0)	Occasionally likely to be disturbed
	Material Risk Score				
3					
Recommended action	D - No Attention Required, Label				
Surveyor comments	Textured coating to ceiling

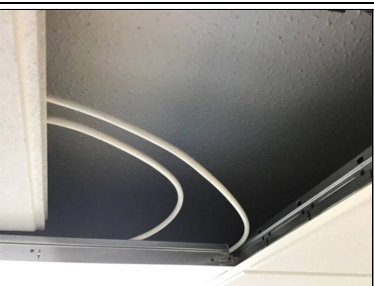
Survey Date:	Lead Surveyor	Survey Type	Floor	Analysis
	21 Dec 2022	Matthew Monro	Management Survey	Ground Floor	Chrysotile (1)
	Building	Room	Item	Quantity	
	St Johns School	Breakfast club G49	Textured coating Ceiling	48m²	
	Sample No (S,SP,P,As)	Product Type	Surface Treatment	Condition	Accessibility
	AB005162 (S)	Textured Coating (1)	Surface Sealed (1)	Good Condition (0)	Usually inaccessible or unlikely to be disturbed
	Material Risk Score				
	3				
Recommended action	D - No Attention Required, Label				
Surveyor comments	Textured coating to ceiling

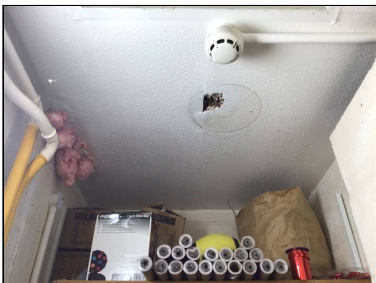
Survey Date:	Lead Surveyor	Survey Type	Floor	Analysis
	21 Dec 2022	Matthew Monro	Management Survey	Ground Floor	Chrysotile (1)
	Building	Room	Item	Quantity	
	St Johns School	Gas cupboard G50	Textured coating Ceiling	2m²	
	Sample No (S,SP,P,As)	Product Type	Surface Treatment	Condition	Accessibility
	As AB005162 (SP)	Textured Coating (1)	Surface Sealed (1)	Good Condition (0)	Usually inaccessible or unlikely to be disturbed
	Material Risk Score				
	3				
Recommended action	D - No Attention Required, Label				
Surveyor comments	Textured coating to ceiling

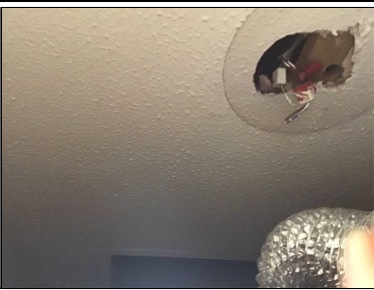
Survey Date:	Lead Surveyor	Survey Type	Floor	Analysis
	21 Dec 2022	Matthew Monro	Management Survey	Ground Floor	Chrysotile (1)
	Building	Room	Item	Quantity	
	St Johns School	Toilet G51	Textured coating Ceiling	2m²	
	Sample No (S,SP,P,As)	Product Type	Surface Treatment	Condition	Accessibility
	As AB005162 (SP)	Textured Coating (1)	Surface Sealed (1)	Good Condition (0)	Usually inaccessible or unlikely to be disturbed
	Material Risk Score				
	3				
Recommended action	D - No Attention Required, Label				
Surveyor comments	Textured coating to ceiling

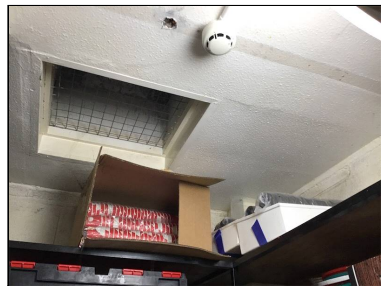
Survey Date:	Lead Surveyor	Survey Type	Floor	Analysis
	21 Dec 2022	Matthew Monro	Management Survey	Ground Floor	Chrysotile (1)
	Building	Room	Item	Quantity	
	St Johns School	Store G52	Textured coating Ceiling	4m²	
	Sample No (S,SP,P,As)	Product Type	Surface Treatment	Condition	Accessibility
	As AB005162 (SP)	Textured Coating (1)	Surface Sealed (1)	Good Condition (0)	Usually inaccessible or unlikely to be disturbed
	Material Risk Score				
	3				
Recommended action	D - No Attention Required, Label				
Surveyor comments	Textured coating to ceiling

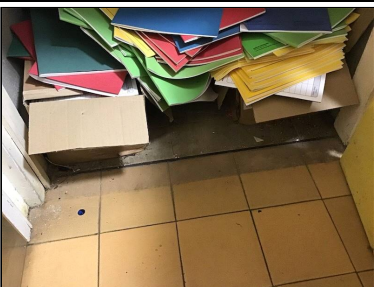
Survey Date:	Lead Surveyor	Survey Type	Floor	Analysis
	21 Dec 2022	Matthew Monro	Management Survey	Ground Floor	Chrysotile (1)
	Building	Room	Item	Quantity	
	St Johns School	Cupboard G53	White tiles and adhesive Floor	1m²	
	Sample No (S,SP,P,As)	Product Type	Surface Treatment	Condition	Accessibility
	AB005163 (S)	Reinforced Composite (1)	Completely Sealed (0)	Low Damage (1)	Easily disturbed
	Material Risk Score				
3					
Recommended action	D - No Attention Required, Label				
Surveyor comments	White floor tiles and adhesive in cupboard

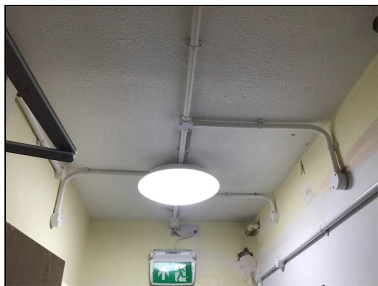
Survey Date:	Lead Surveyor	Survey Type	Floor	Analysis
	21 Dec 2022	Matthew Monro	Management Survey	Ground Floor	Chrysotile (1)
	Building	Room	Item	Quantity	
	St Johns School	Lobby G54	Textured coating Ceiling	3m²	
	Sample No (S,SP,P,As)	Product Type	Surface Treatment	Condition	Accessibility
	As AB005162 (SP)	Textured Coating (1)	Surface Sealed (1)	Good Condition (0)	Usually inaccessible or unlikely to be disturbed
	Material Risk Score				
	3				
Recommended action	D - No Attention Required, Label				
Surveyor comments	Textured coating to ceiling

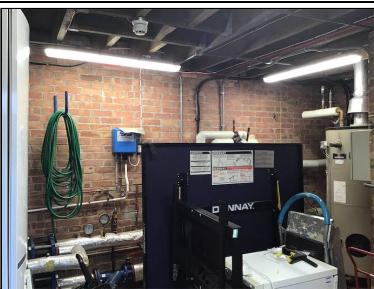
Survey Date:	Lead Surveyor	Survey Type	Floor	Analysis
	21 Dec 2022	Matthew Monro	Management Survey	Ground Floor	N/A
	Building	Room	Item	Quantity	
	St Johns School	Electrical cupboard G55	No suspect materials found	N/A	
	Sample No (S,SP,P,As)	Product Type	Surface Treatment	Condition	Accessibility
	Visual	N/A	N/A	N/A	N/A
	Material Risk Score				
	N/A				
Recommended action	No further action required				
Surveyor comments	N/A

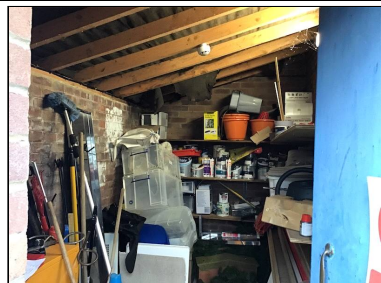
Survey Date:	Lead Surveyor	Survey Type	Floor	Analysis
	21 Dec 2022	Matthew Monro	Management Survey	Ground Floor	N/A
	Building	Room	Item	Quantity	
	St Johns School	Garden store G57	No suspect materials found	N/A	
	Sample No (S,SP,P,As)	Product Type	Surface Treatment	Condition	Accessibility
	Visual	N/A	N/A	N/A	N/A
	Material Risk Score				
	N/A				
Recommended action	No further action required				
Surveyor comments	N/A

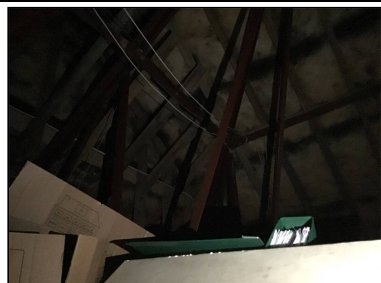
Survey Date:	Lead Surveyor	Survey Type	Floor	Analysis
	21 Dec 2022	Matthew Monro	Management Survey	Roof Void	N/A
	Building	Room	Item	Quantity	
	St Johns School	IT room loft space R01	No suspect materials found	N/A	
	Sample No (S,SP,P,As)	Product Type	Surface Treatment	Condition	Accessibility
	Visual	N/A	N/A	N/A	N/A
	Material Risk Score				
N/A					
Recommended action	No further action required				
Surveyor comments	N/A

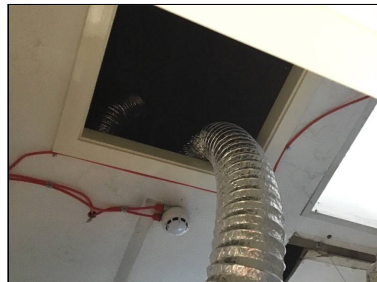
Survey Date:	Lead Surveyor	Survey Type	Floor	Analysis
	21 Dec 2022	Matthew Monro	Management Survey	Roof Void	N/A
	Building	Room	Item	Quantity	
	St Johns School	Boys toilet loft space R02	Inaccessible	N/A	
	Sample No (S,SP,P,As)	Product Type	Surface Treatment	Condition	Accessibility
	Visual (P)	N/A	N/A	N/A	N/A
	Material Risk Score				
N/A					
Recommended action	Inspection Required				
Surveyor comments	No access into loft space due to suspended ceiling.

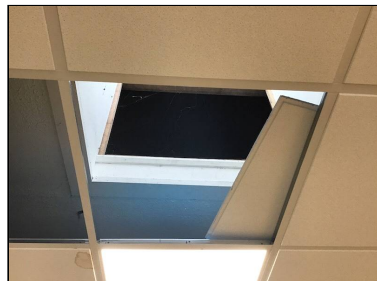
Survey Date:	Lead Surveyor	Survey Type	Floor	Analysis
	21 Dec 2022	Matthew Monro	Management Survey	Roof Void	N/A
	Building	Room	Item	Quantity	
	St Johns School	Year 12 classroom loft space R03	Inaccessible	N/A	
	Sample No (S,SP,P,As)	Product Type	Surface Treatment	Condition	Accessibility
	Visual (P)	N/A	N/A	N/A	N/A
	Material Risk Score				
N/A					
Recommended action	Inspection Required				
Surveyor comments	No access into loft space due to suspended ceiling
